Service Bulletin

Bulletin No.: PI1116

Subject: Door Rattle Noise from Outside of Vehicle During High Radio Volume or High Bass Levels

Models: 2014 Chevrolet Corvette
Built Prior to VIN Breakpoint E5105000

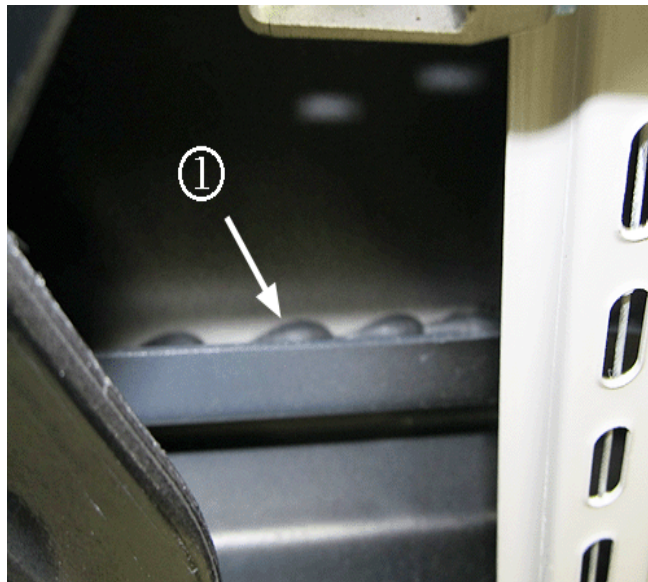
3652282

The cause of this condition may be voids in adhesive (1), leaving gaps between the inner door beam and the door skin.

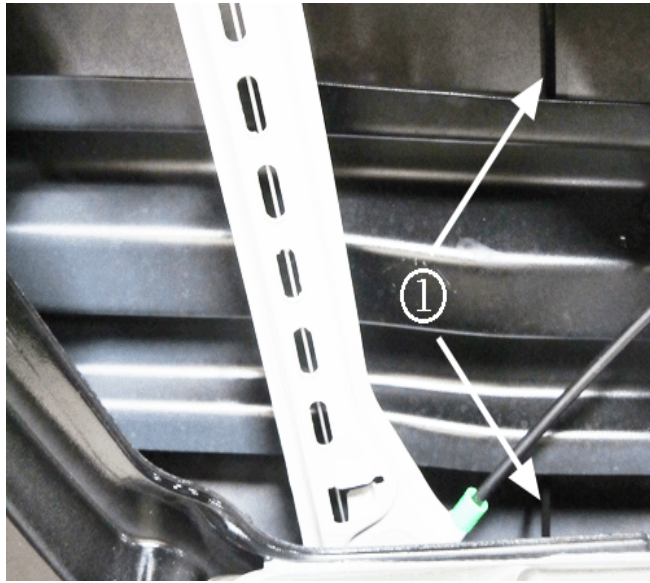
3652284

The graphic above shows an example in which a tie strap (1) was passed through a 15-20 cm (6-8 in) length gap where the adhesive was missing towards the center of the door.

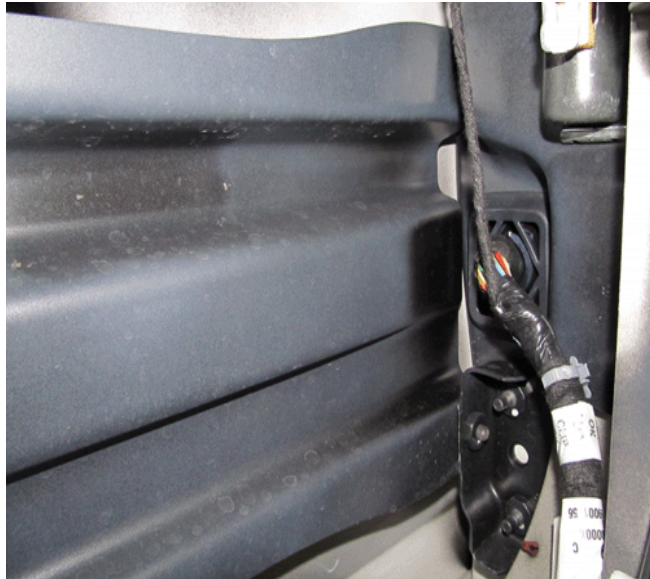
3652286

This can also occur in the front and/or rear area of the door beam; with the condition sometimes more evident in the front area (shown above) where the radio speaker is mounted.
