# Service Bulletin

Bulletin No.: PI1133

**Subject:** Rear Compartment (Trunk) Water Leak

**Models:** 2014 Chevrolet Impala Built After April 22, 2013

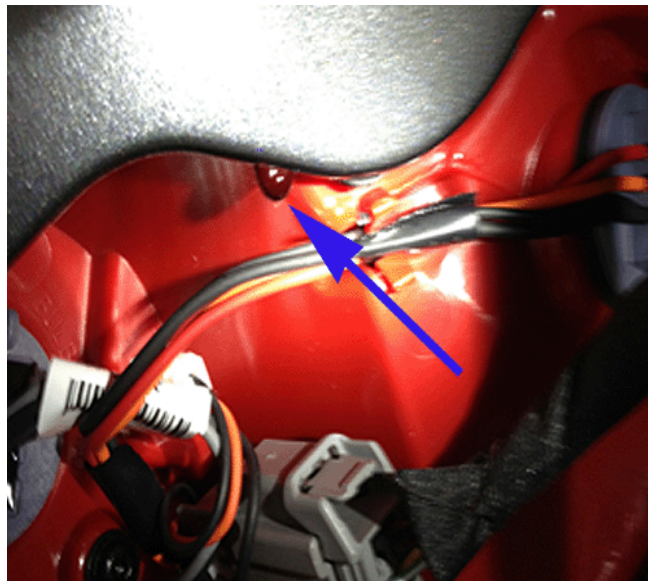
3612263

Some customers may comment that water is getting into the rear compartment area floor or the trim panels are damp.

This condition may be caused by the tail lamp seal on the body mounted (outboard) lamp assembly not sealing to the vehicle body.

1. Water test the vehicle and determine if the water is coming in through the left and/or right tail lamp area. Refer to Waterleaks in SI.
2. If water is detected in one or both of the tail lamp areas, remove the left and right tail lamp assemblies. Refer to Tail Lamp Replacement - Outboard in SI.
