Service Bulletin

Bulletin No.: PI1137

Subject: Temperature and Blower Speed Knobs Difficult to Rotate and/or Make a Clicking Noise

Models: 2014 Chevrolet Corvette
Condition/Concern

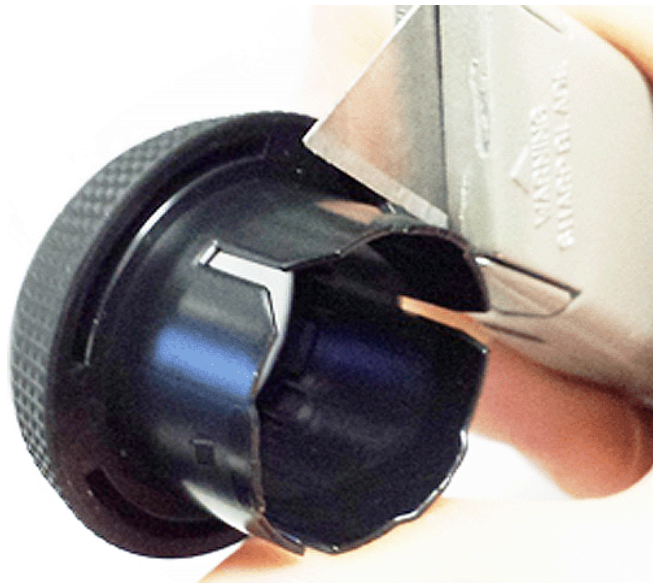
3669835

Some customers may comment that the knobs are difficult to turn and/or make a clicking noise when attempting to adjust the blower speed or the interior temperature on the HVAC control.

2. With a sharp tool, remove the red portion of each detent as shown above.

Important: Be sure not to remove too much or all of the detent. The HVAC control knob will not seat and be loose if too much material is removed.
