# Service Bulletin

Bulletin No.: PIC5317A

**Subject:** Tapping Noise Heard In Vehicle While Driving

**Models:** 2010 - 2013 Buick LaCrosse

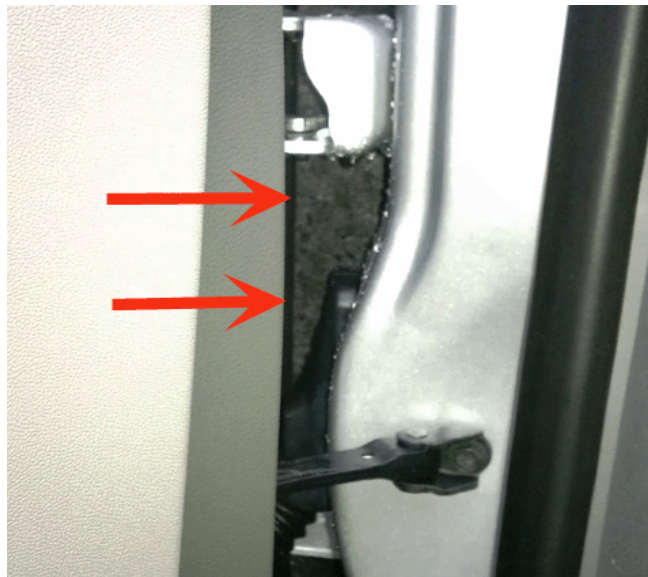
3404866

The following photo shows the insulator in the correct position:

Lift vehicle and inspect for loose or undersized push pin retainers in both left and right side front fender liners.

Inspect for insulators being securely in place behind front wheel liners and reposition as necessary. Replace push pins as necessary.
