Service Bulletin

Bulletin No.: PIC5360B

Subject: Intermittent No Crank No Communication To High Speed LAN Modules

Models: 2010 - 2013 Chevrolet Camaro

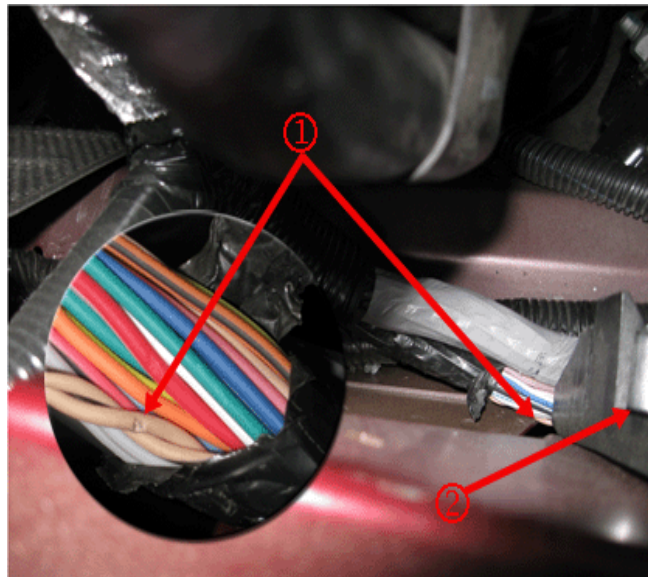
2503475

There are two (2) locations on the vehicle to inspect for this concern depending on what options it is equipped with. The first area of concern is the engine wiring harness (1) under the ECM (2). Technicians are to check for possible chaffing of this wiring harness on the inner fender panel. An example of this concern can be seen in the photo below.

Repair the wiring, install conduit on this area of the harness, and relocate the harness away from the panel to protect it from future damage.

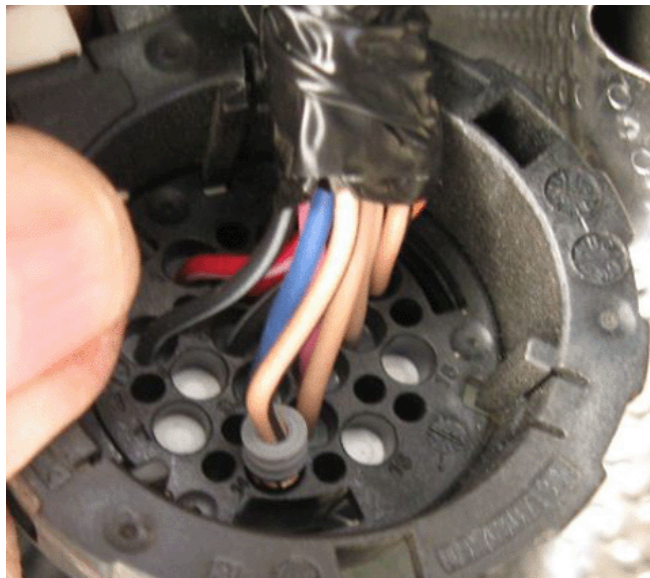
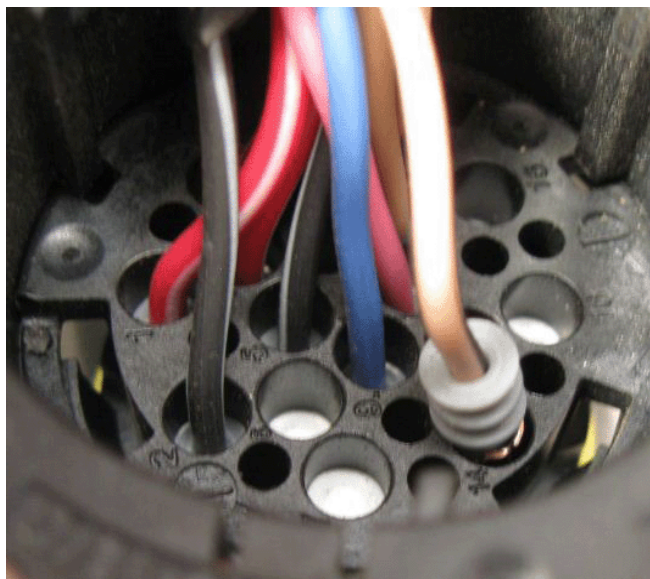
The second area of concern relates to vehicles equipped with an automatic transmission only. Reports from the field have shown that a HSLAN circuit terminal may not be seated properly in the round TCM connector located in the transmission. Technicians are to inspect this TCM connector for any data line circuits that may be not fully seated in the plastic connector. If this concern is found, carefully inspect the condition of both halves of the plastic connector

The two photos below show an example of circuit 2500 backed out of the TCM connector. Be sure to inspect ALL terminals in this connector while it is disconnected.

as well as both the male and female terminals. If the female terminal was simply not seated correctly, push on the wire until the terminal clicks back into position. Lightly tug on the wire to make sure it is fully seated. If it pulls back out, replace the terminal and/or connector as needed. After reinstalling the connector to the TCM, lightly tug on the wire again to make sure it did not become disengaged during reassembly. If the male terminals or the TCM half of the connector is damaged, the entire TCM will require replacement. This module is internal to the automatic transmission assembly.
