Service Bulletin

Bulletin No.: PIC5626A

Subject: BAS+ (Hybrid) eAssist Service Charging System Message, MIL On With or Without DTCs P0A8F and P062F

Models: 2012 - 2013 Buick LaCrosse, Regal eAssist
2013 Chevrolet Malibu ECO eAssist
All with RPO HP6

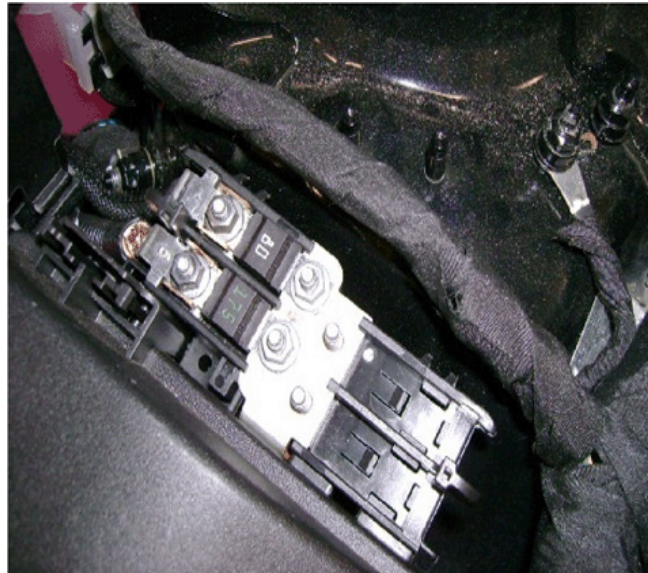
2752041

If the fuses show voltage stress is present, this is most likely the result of a poor connection. The Fuses are now available individually. If the entire fuse block needs to be replaced for any reason the fuse block includes both fuses.

If the fuses pass inspection and they are not visually damaged in any way, install the fuses, carefully torque them to 4.7 Nm (42 lb-in), and re-evaluate the charging system operation. If the 175A fuse is open or has a poor connection, a P0A8F may be stored in history but the DTC may not consistently reset.
