Loose Windshield Dam at Lower Right Corner of Windshield

Service Category Vehicle Interior

Section Interior Panels/Trim

YEAR(S)	MODEL(S)	ADDITIONAL INFORMATION
2012 – 2013	Prius C

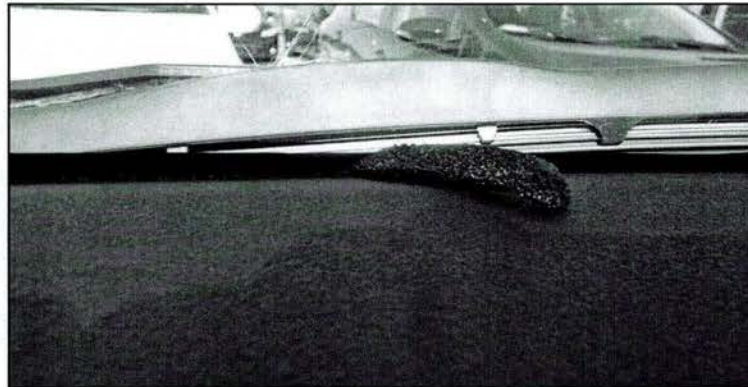
Figure 1.

Some 2012 – 2013 model year Prius C vehicles may exhibit a condition where a piece of foam that fits between the instrument panel and the windshield may come loose. Parts have been revised to address this condition.
