MIL "ON" DTC P0A80 or P0A7F due to Dust or Debris in HV Battery Cooling Fan

Service Category Engine/Hybrid System

Section Hybrid/Battery Control System

YEAR(S)	MODEL(S)	ADDITIONAL INFORMATION
2012	Camry HV

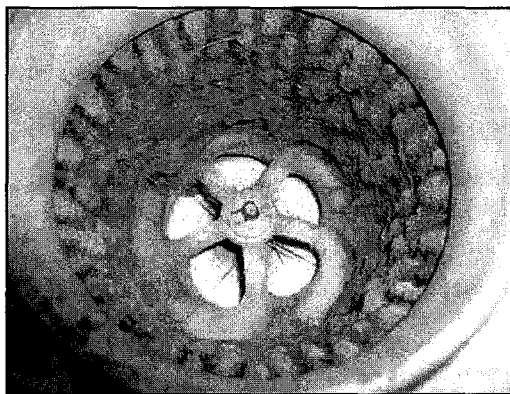
Figure 1.

Some 2012 model year Camry HV vehicles may exhibit a MIL "ON" condition with Diagnostic Trouble Code (DTC) P0A80 or P0A7F stored due to dust or debris build-up in the HV Battery Cooling Fan. Use the following repair procedure to address this condition.

Is the HV Battery Cooling Fan clogged with dust or debris build-up? Refer to Figure 1 for an example of a clogged cooling fan.

2. Clean dust and debris build-up from the HV Battery Cooling Fan with compressed air or vacuum.

3. Replace the HV Battery Assembly.
