SERVICE BULLETIN

APPLICABILITY: 2010-2013 Legacy and Outback Models **NUMBER:** 07-72-13
SUBJECT: Sunroof Does Not Open or Close Properly **DATE:** 01-29-13
 Popping or Slamming Sound When Glass Lowers
 Prior To Opening

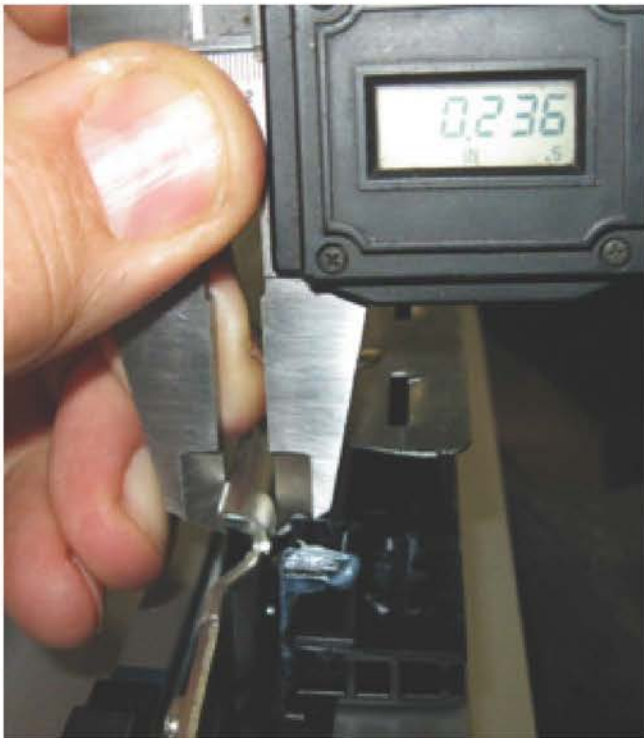
Original Cable Bracket

While the rail (sunroof frame) assembly remains virtually unchanged, significant revisions have been made to the cable assemblies (lid brackets) to increase their durability, rigidity and ease of operation as shown in the photos below.

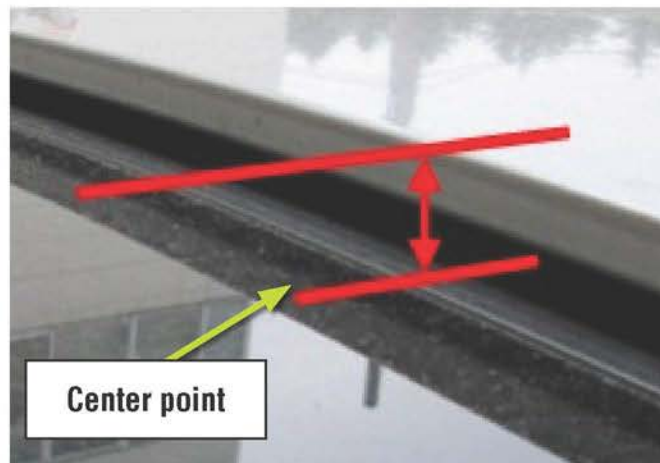
- Open the sunroof to the point where the rear edge of the glass is fully dropped down, just before it retracts under the roof panel.
 - o Determine the center point of the back edge of the glass panel by measuring from the outside edges in toward the middle from each side.
 - o Measure the distance between the top outside edge of the roof opening flange and the glass panel as shown in the photo below.

The standard values are 21.7 mm for Legacy, and 21.9 mm for Outback.

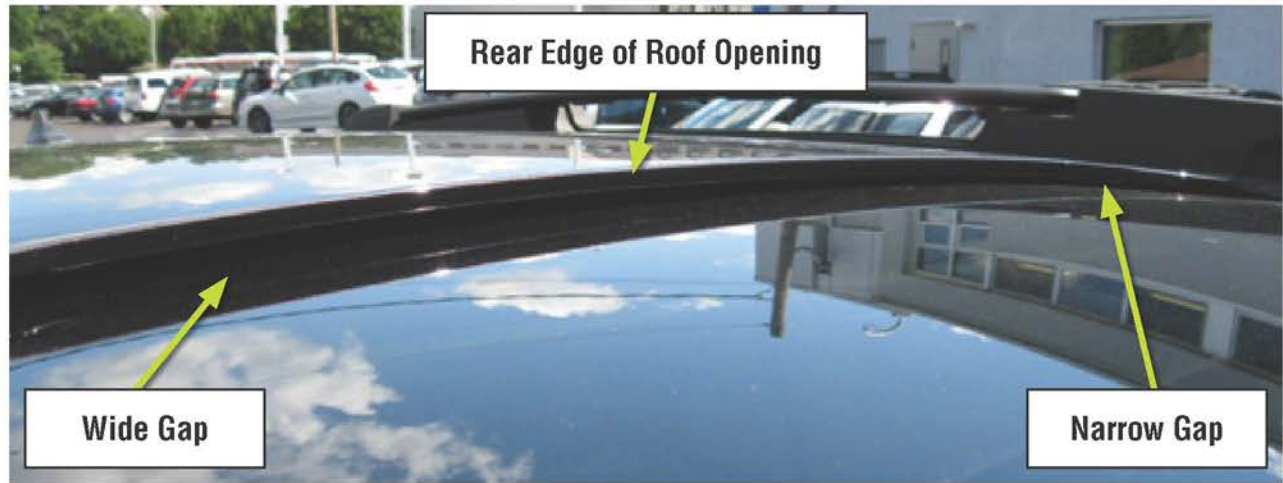
If the measurement is correct, inspect the gap from side to side and make sure it is even (one side is not higher or lower than the other). The photo below shows an Outback sunroof with the left (driver's) side of the glass panel much higher (narrow gap) than the right.

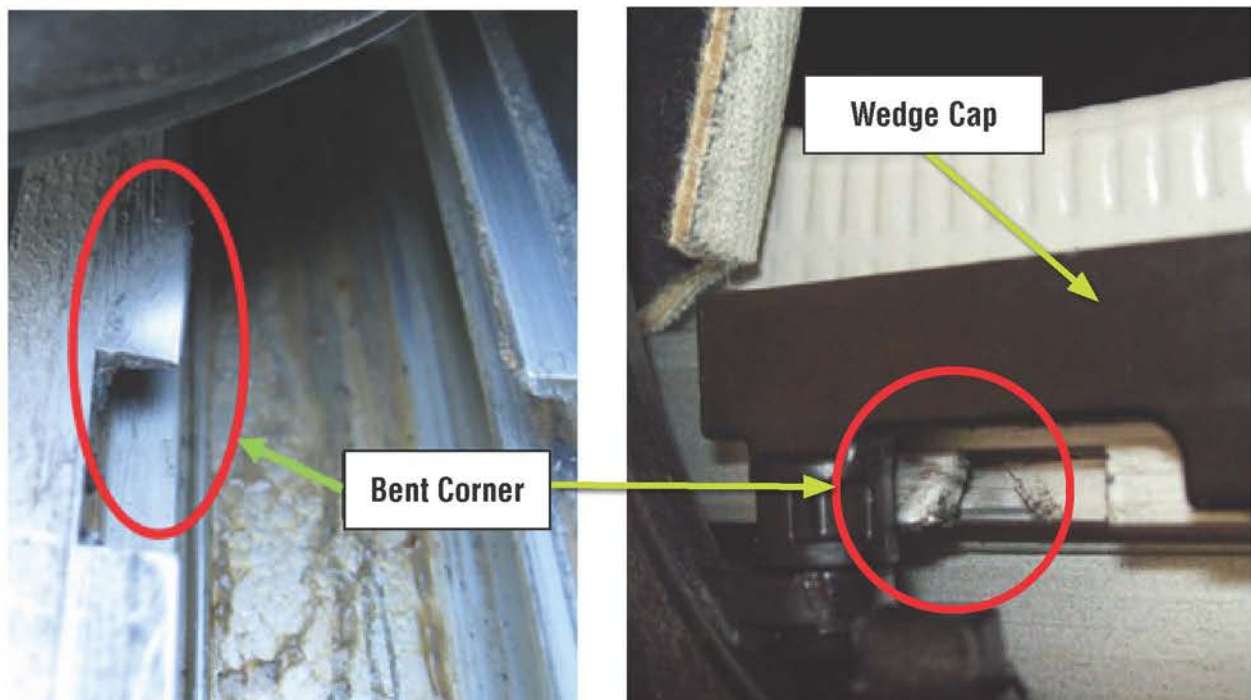
In this case, although the sunroof on this vehicle is operational, the corners of the rectangular openings in the side rails have become deformed (bent) as shown in the photos below. This keeps the lid bracket shoe from dropping into the rectangular opening in the side rail as it should. Instead, when the glass panel retracts, the lid bracket shoe rides on top of the side rail instead of inside the channel causing the condition shown in the photo above. Again, if any deformation of the rail or the wedge cap is confirmed, replacement of the rail assembly along with both cable assemblies is required.

- Order the necessary replacement parts as per the chart on Page 1.
- Record radio station presets (and navigation system favorites if applicable).
- Disconnect the battery.

- Transfer the sunshade to the new frame assembly.
- Fit the new cable assemblies to the frame then re-install the sunroof assembly.
- Reconnect the battery.
- Perform the sunroof motor initialization procedure outlined in the applicable Service Manual.
- Confirm proper operation of the sunroof’s tilt, open, and close functions along with the auto-reverse safety feature.
- Take time to make sure **all** trim panels are reinstalled properly.
- Wipe off any dirt, grease or smudges with a clean cloth.
- Reset the radio station presets (and navigation system favorites if applicable).
