## Exhaust Band Clamp Torque CHU, CXU, TD

### PI0829, Exhaust Band Clamps Torque

(August 2013)

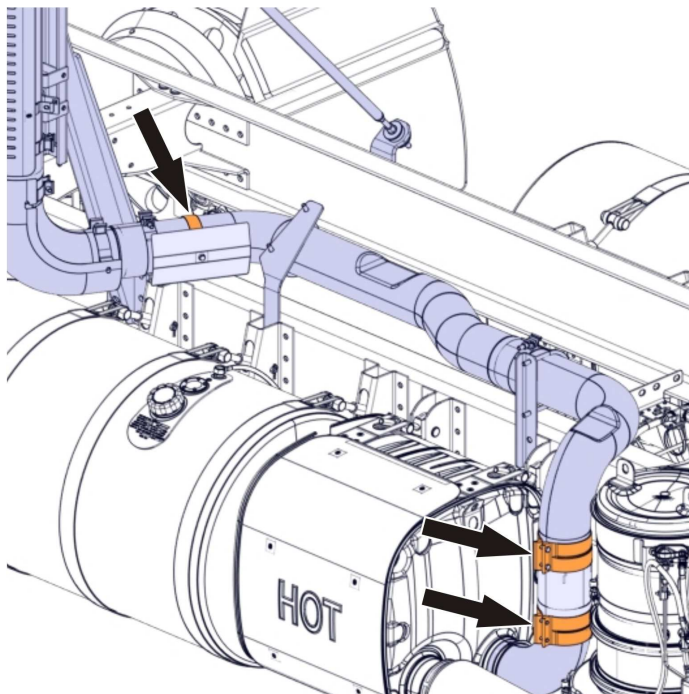
W2083859

The aftertreatment selective catalytic reduction (SCR) outlet pipe band clamps and heat shield fastener on certain MACK vehicles built between June 28, 2013 and July 23, 2013 were not torqued correctly. Follow the procedure below to tighten the fasteners to specification.

- 1 Secure the vehicle for service by parking it on a flat level surface, applying the parking brake, chocking the rear wheel, and placing the transmission in neutral.
- 2 Tighten SCR outlet pipe hose clamps to  $70 \pm 10$  Nm ( $50 \pm 7$  lb-ft) and tighten heat shield band clamp to  $55 \pm 5$  Nm ( $40 \pm 4$  lb-ft)..
