Mack Trucks, Inc.
Greensboro, NC USA

Field Service Bulletin Trucks

FSB 373-018, Transmission Connector (Multiple Open Circuits)

(November 2013)

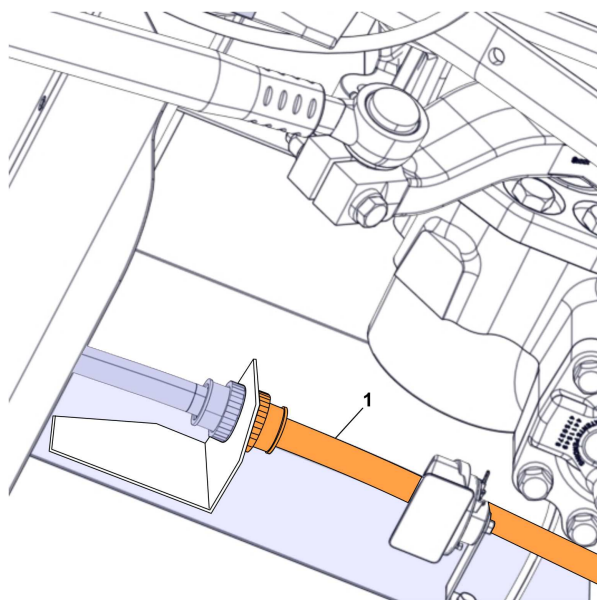
W3085373

On some Mack models built with an Allison transmission, between May 16, 2011 and August 9, 2013, may experience multiple open circuits in the 31 way transmission connector. This is due to a supplier manufacturing issue with the connector. If this issue is found follow the procedure below:

1. Approximate location of "Yellow" marking

4. Look for yellow marking on harness (1).
 - a. If marking is present then no further action required. (Lower the cab).
 - b. If **NO** marking present, see repair below.

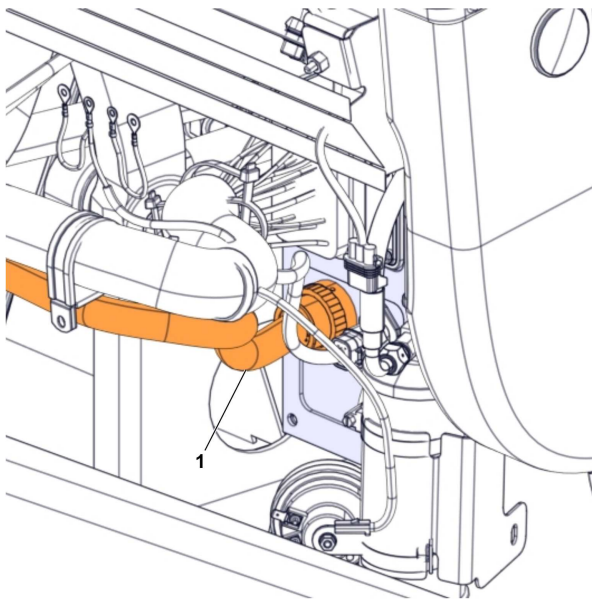
W3085374

1. Approximate location of "Yellow" marking
3. Inspect harness for "Yellow" marking on harness (1).
 - a. If marking is present then no further action required.
 - b. If **NO** marking is present, see repair below.

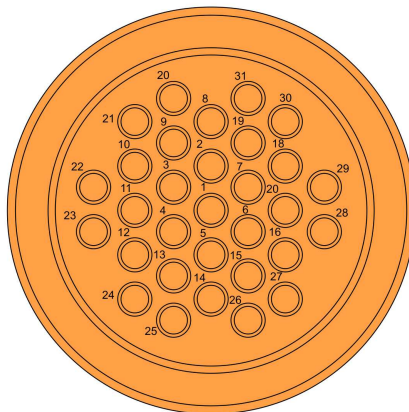
W3084149

Male Pin

- 5 Remove the transmission connector.
- 6 Untape and remove back shell and discard.
- 7 Remove the tape from the harness approximately 152 mm (6 in.) back from the connector.
- 8 Extract the terminals from the Delphi connector one terminal at a time and insert it into the same cavity of the Deutsch connector.

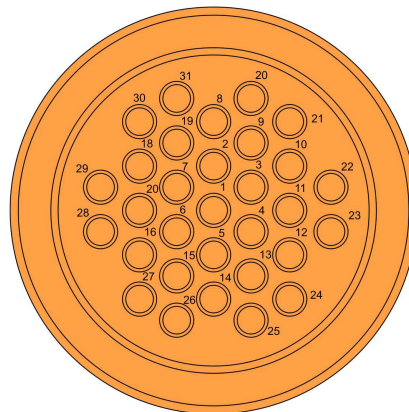
W3084150

Female Socket
