## Turbocharger Outlet Flex Pipe LEU, MRU

### PI0834, Turbocharger Outlet Flex Pipe

(November 2013)

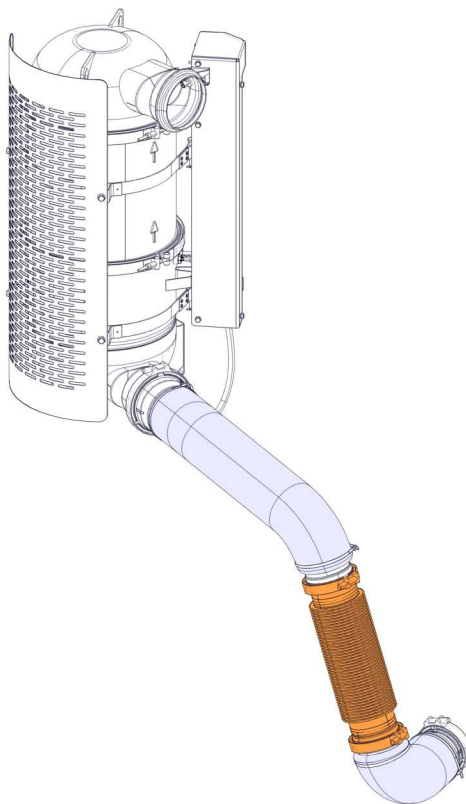
W2085297

Due to a durability issue with the turbocharger outlet flex pipe, it has been decided to replace the flex pipe on all Mack LEU and MRU vehicles with a MP7 or MP8 engine built between April 1, 2013 and October 13, 2013. Replace flex pipe part number 21959391 with flex pipe part number 21428530.

**Note:** To obtain the optimum life from the pipe, it should be installed straight.

**Note:** Flex pipe **MUST** be installed as straight and parallel to the turbocharger outlet pipe and DPF inlet pipe as possible.

**Note:** Flex pipe should NOT be installed in a curved manor.
