Field Service Bulletin Trucks

Date	Group	No.	Release	Page
10.2013	284	047	02	1(9)

Oil Level Sensor Harness Wire Splice
CHU, CXU, GU, LEU, MRU, TD

FSB 284-047, Oil Level Sensor Harness Wire Splice

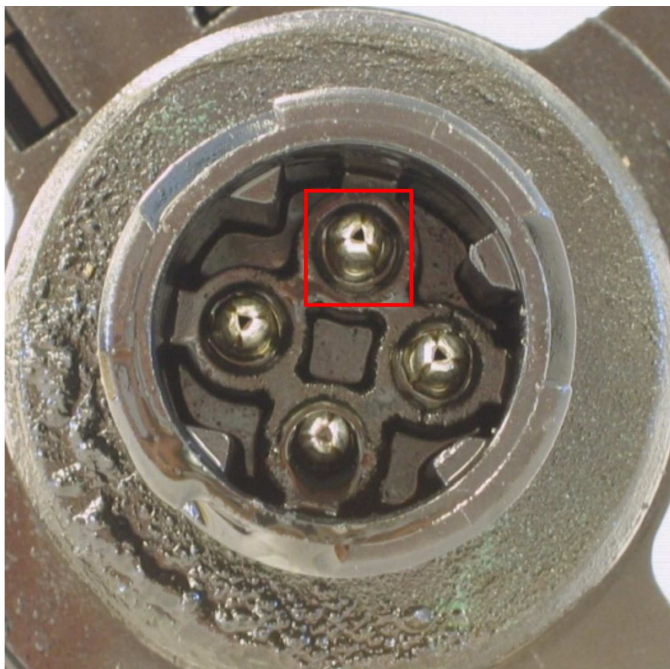
W2085817

Some MACK vehicles with MP engines built between January 2004 and September 19, 2013 may experience an oil level sensor failure that leads to oil contamination into the engine wire harness. A new anti-wicking pigtail splice kit, part number 85137983, is now available. Follow the procedure below if wicking is observed. Chassis with build date September 20, 2013 and later have the new solid pin connector and no action is required. The oil level sensor part number 21521353 with hollow pin type connector is now replaced with the new solid pin type connector oil level sensor part number 22022794. The new solid pin connector does not allow oil to wick into the engine harness.

Old Style Hollow Pin Connector

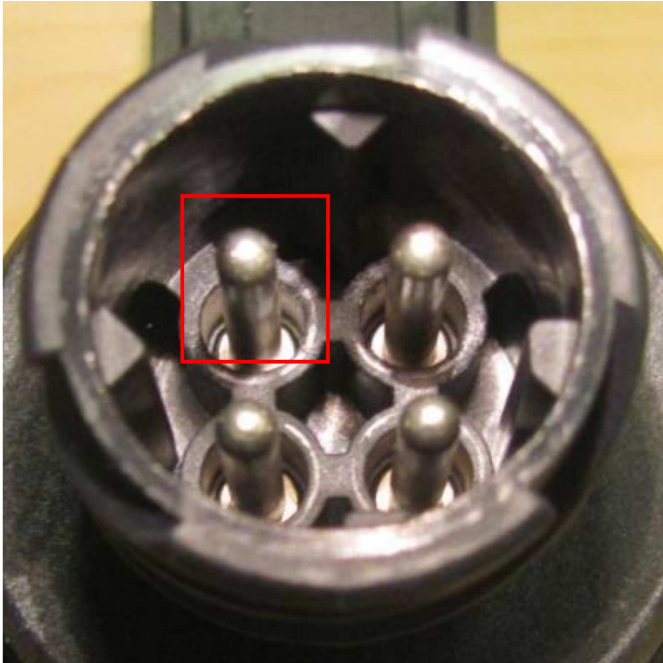
W2085818

New Style Solid Pin Connector

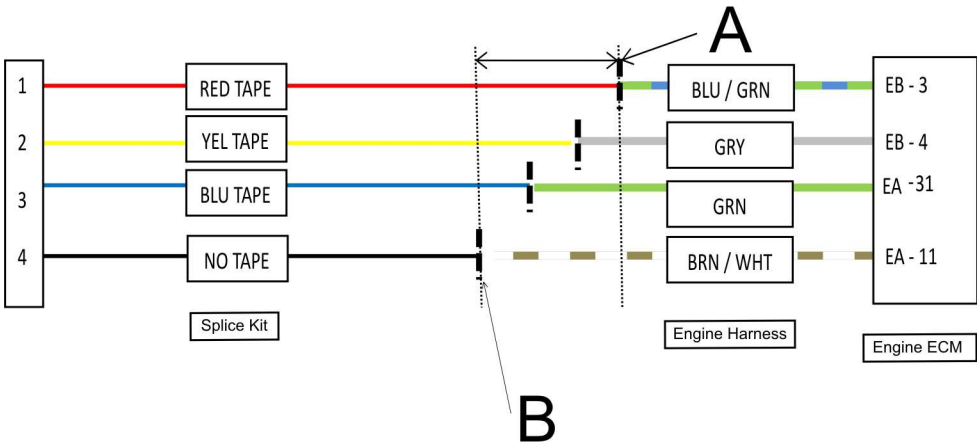
W3085820

A.	Length of cut harness plus 75 mm (3 in) to allow the splice stagger
B.	Length of initial harness cut

10 Stretch the wires together and clip one wire from the splice kit to the same length as the wires on the contaminated harness. Cut the rest of the wires in the splice kit in a staggered pattern at increasing lengths. The length from the shortest wire to the longest wire should be approximately 75 mm (3 in). Install the previously removed loom over the splice kit connector.
