Battery Starter Lug Failure CXU, GU

FSB 371-045, Battery Cable Lug, Failure

(May 2013)

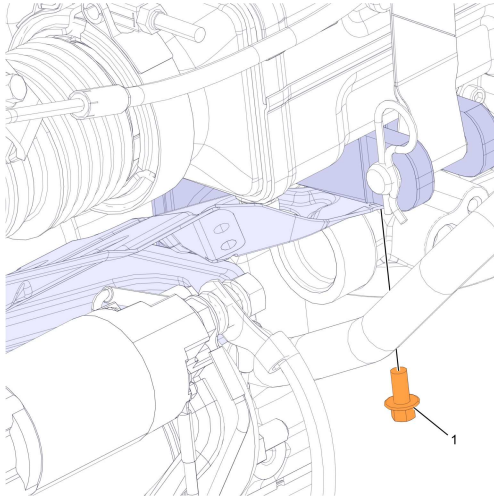
W2080360

1. Screw

- 1 Secure the vehicle for service by parking it on a flat level surface, applying the parking brake, chocking the rear wheel, and placing the transmission in neutral.
- 2 Disconnect all cables from the negative (ground) battery terminals to prevent personal injury from electrical shock and prevent damage to electrical components.
- 3 Remove the fastener from the heat shield bracket.

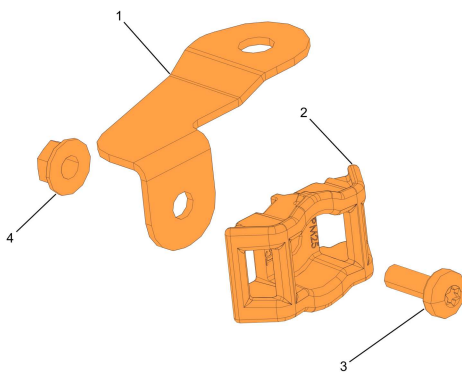
W2080361

- 1 Bracket
- 2 Saddle
- 3 Socket Screw
4. Nut

- 4 Preassemble the bracket and the saddle.

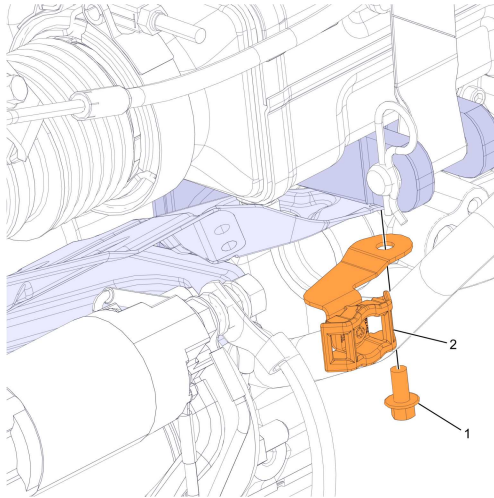
W2080362

1. Socket Screw
2. Saddle

- 5 Install the bracket onto the vehicle and secure.

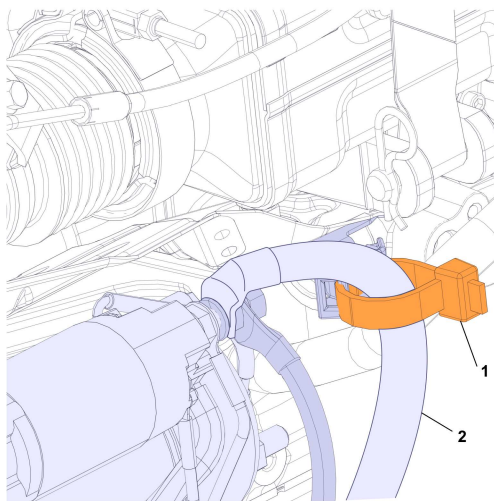
W2080364

1. Cable Tie
2. Positive Battery Cable

- 6 Install the cable tie around the saddle and the positive battery cable going to the starter solenoid.

Note: Battery cable may need to be loosened/retightened from back of starter solenoid in order to reach the saddle. Tighten to 26 ± 1.5 Nm (19.2 ± 1.1 ft lb).
