**SUBARU.****QUALITY DRIVEN® SERVICE****SERVICE BULLETIN**

APPLICABILITY: 2013MY Legacy and Outback 2.5L Models
 2012-13MY Impreza 2.0L Models
 2013MY XV Crosstrek
 2011-2014MY Forester NA Models Only
 2013MY BRZ

NUMBER: 11-130-13
DATE: 04/05/13

SUBJECT: Difficulty Starting, Rough Idle, Cam Position or Misfire DTCs
 P0340, P0341, P0345, P0346, P0365, P0366, P0390, P0391,
 P0301, P0302, P0303 or P0304

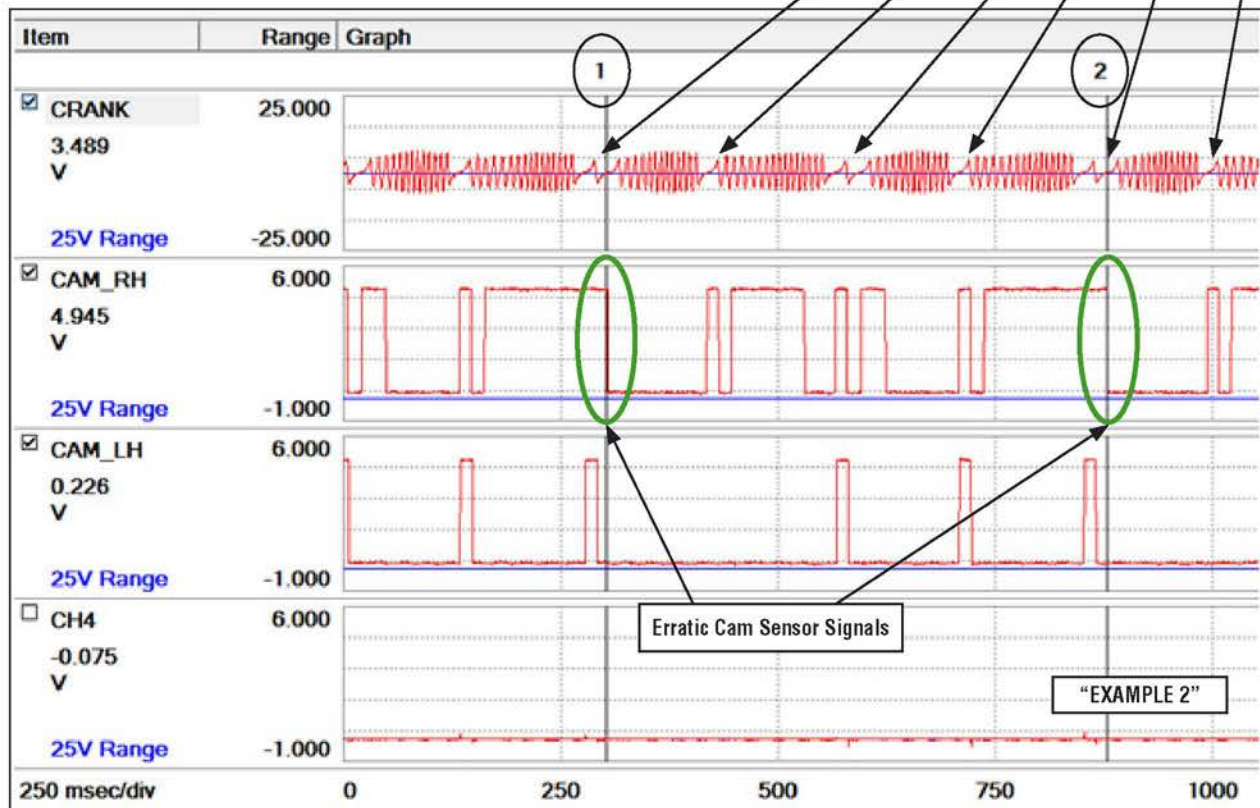
Example 2 below shows a “Bad” pattern for the RH cam sensor. Marks #1 and #2 show what appears to be #4 cylinder firing but, the next cylinder to fire according to the screen shot is #2 followed by #4 then #1. The pattern for the RH sensor never shows the proper sequence to fire #3 cylinder. In this case, recheck the data again after installing a .2mm shim under the RH cam sensor.

Proper Firing Order is: #3 #2 #4 #1 #3 #2

Firing Order shown in screen shot: #4 #2 #4 #1 #4 #2

IMPORTANT: If you confirm an irregular wave form pattern, BEFORE performing the measurement and shim selection procedures, install a .2mm shim under the suspect intake or exhaust camshaft position sensor. If there is no change, remove the .2mm shim and install a .4mm shim. **USE ONLY ONE SHIM PER SENSOR, NO STACKING.** If the wave pattern is lost, remove the .4mm shim and replace with a .3mm shim. Recheck the pattern and if it appears normal, complete the repair as shown below. If an abnormal pattern persists, proceed with the rest of the clearance measurement and shim selection procedures.

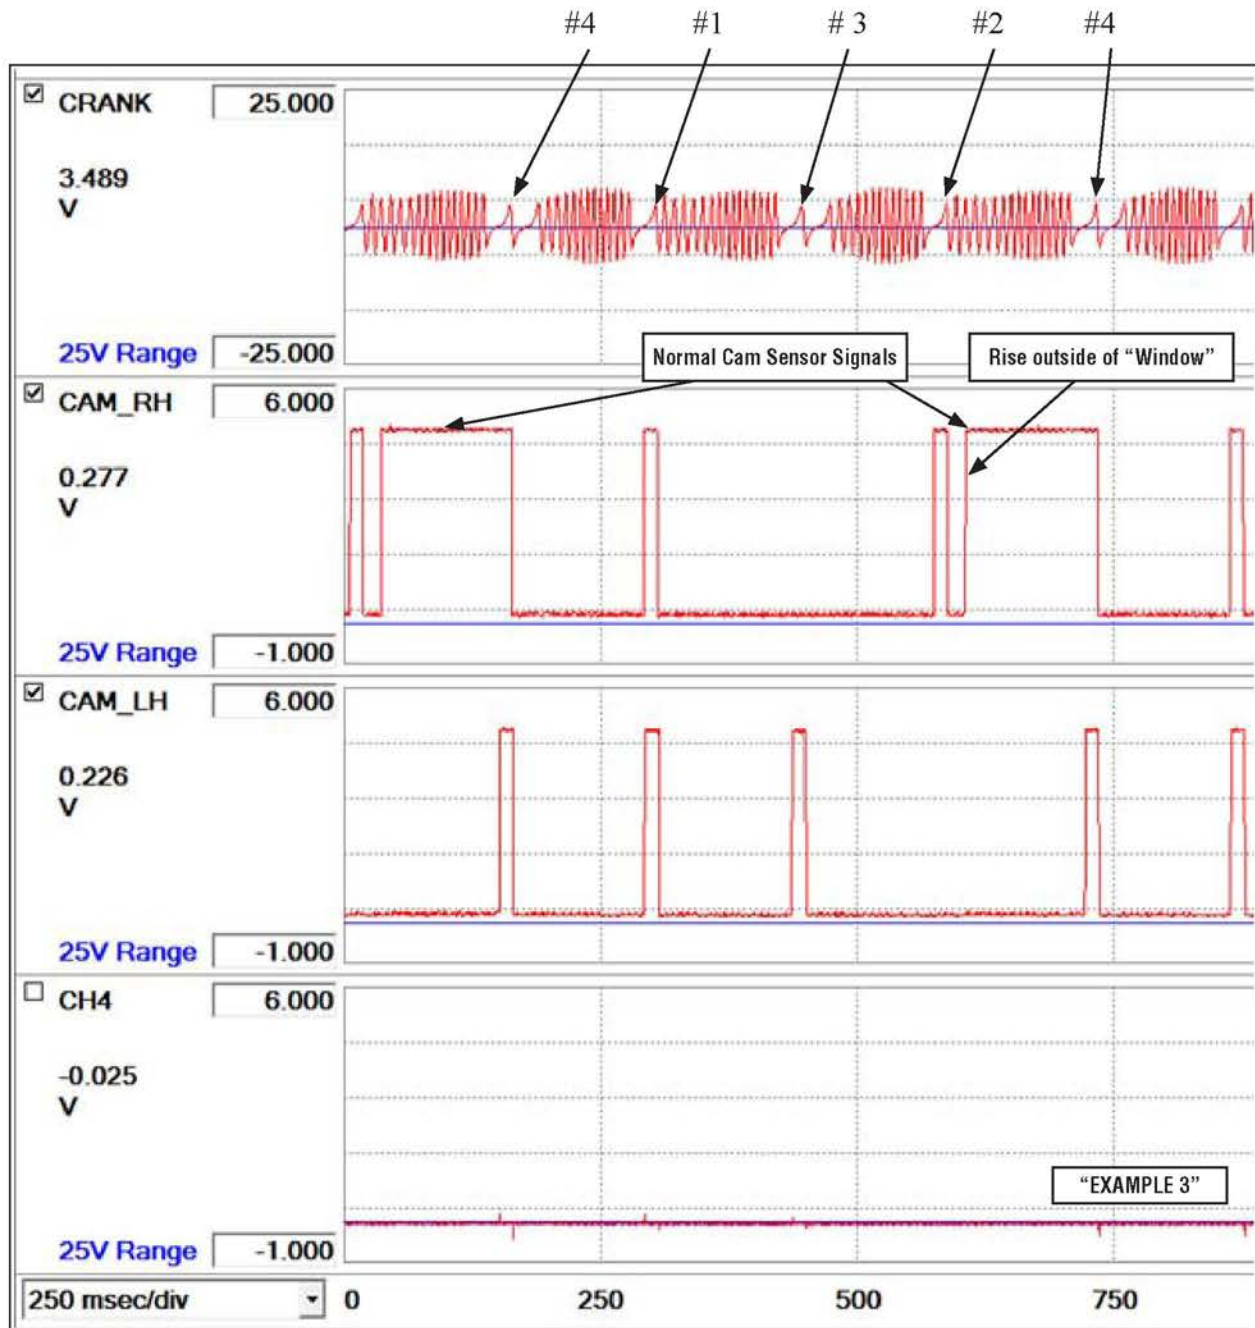
Example 3 shows what appears to be an erratic signal from the RH cam sensor but, you can see all the cam sensor data signal edges (drops) follow the chart and firing order as they are supposed to. Other signal edges (rises or drops) outside the “window” or a longer time line as shown here prior to the #4 signal edges seen on the RH cam sensor pattern are examples of signals which will be “ignored” by the ECM and are not a cause for concern.

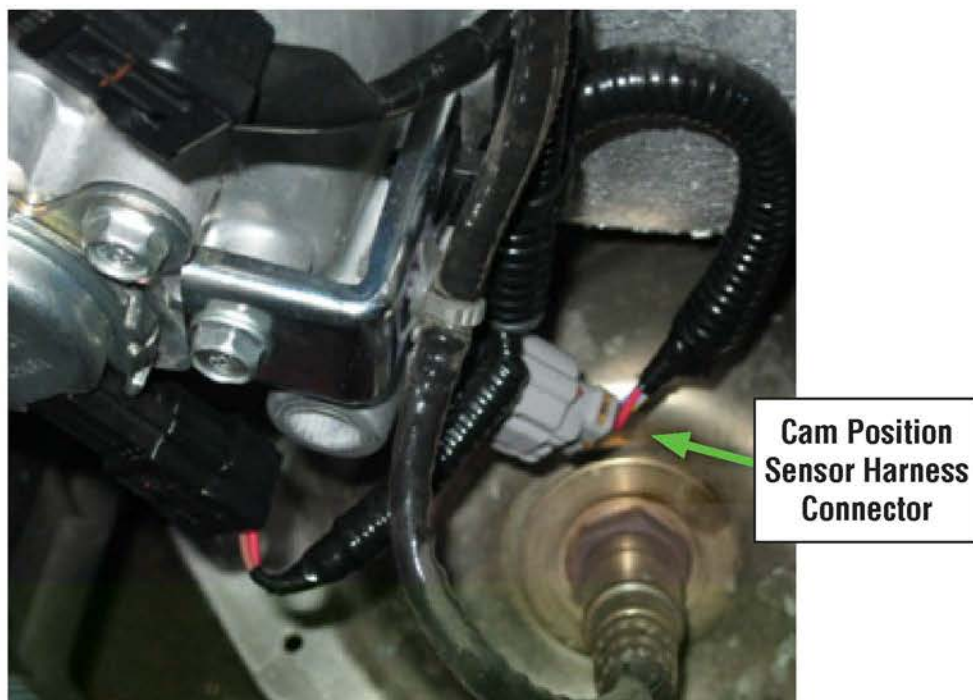
In the event you have a DTC stored for an exhaust camshaft position sensor, the repair procedure has been revised. Due to the position of the right-hand (Bank 1) sensor, measurement of the gap without removing the front catalyst is extremely difficult as shown in the photo below.

1. Confirm the irregular oscilloscope pattern for the corresponding DTC stored.
2. Remove the sensor from the timing cover and install a .2mm thick shim from the applicable kit.
3. Reinstall the sensor, torque the sensor retaining bolt to 6.4 Nm (4.7 ft. lbs. or 56.4 inch-pounds) then recheck the oscilloscope pattern.

If the pattern is normal, the repair is complete. If the irregular pattern persists, repeat Steps 2 and 3 after removing the .2mm shim and installing a .3 mm thick shim. **ONE SHIM ONLY, NO STACKING.** Repeat as necessary increasing the shim thickness .1 mm at a time until a normal scope pattern can be verified.
