## SERVICE BULLETIN

**APPLICABILITY:** 2012MY Impreza

**NUMBER:** 12-148-13

**SUBJECT:** “Rattle” or “Popping” Sound From Rear Door Area

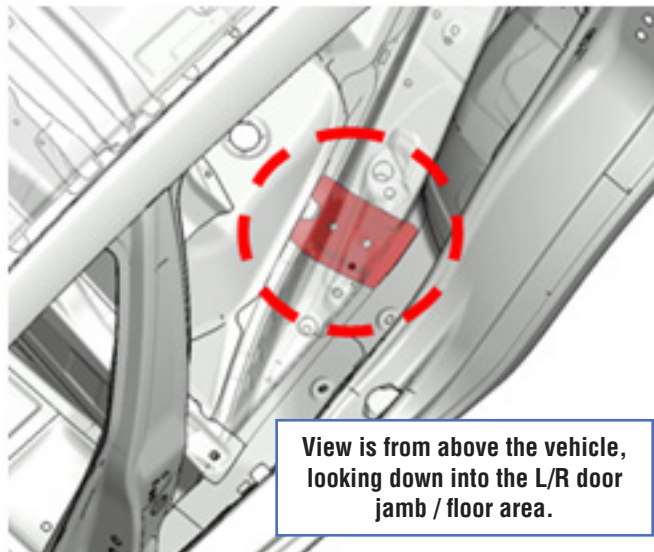
This bulletin provides a repair procedure to address a customer concern of a “rattle” or “popping” sound which could come from either of the rear door opening areas. The sound may occur over small bumps or when a twisting motion is introduced into the vehicle body at low speeds. The cause is an insufficient gap between multiple layers of the body structure where they are spot-welded together as shown in the illustrations below.

View is from above the vehicle, looking down into the L/R door jamb / floor area.

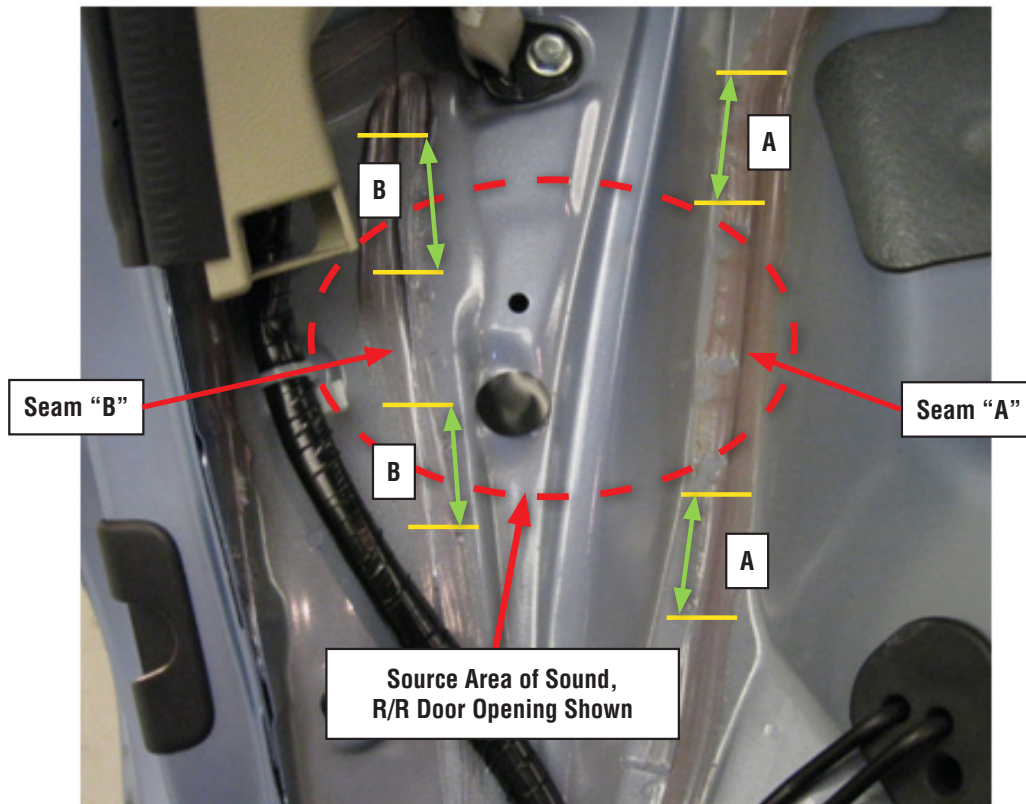
1. Remove the rear seat cushion and the door sill trim panel to access the affected area shown below following the procedures outlined in the applicable Service Manual. Once the seat cushion and trim are removed, road test the vehicle again to confirm the area circled in the photo below is the source of the sound.

2. Remove the sealer from the seam "A" areas shown in the photo above using a scraper.
3. Next, using a pick tool as shown in the photo below, remove the sealer from between the layers of sheet metal.

4. Once the sealer has been removed, using a flat-blade screw driver, carefully work it in between the layers of sheet metal and increase the gap in the areas between the spot-welds in the two “A” sections shown on page 2 first. Only spread the layers enough to allow the spray grease to penetrate (Step 7).

5. Next, road test the vehicle again to confirm whether or not the sound has been eliminated.
6. If the sound persists, repeat Steps 2 - 5 on the “B” sections shown on page 2.
