SERVICE BULLETIN

APPLICABILITY: 2012-13MY Impreza and WRX STI
 2013MY Legacy, Outback, BRZ and XV Crosstrek
 2012-14MY Forester

NUMBER: 15-164-13

SUBJECT: Fujitsu Ten (F10) SD Card Audio/Navigation System
 Operation Tips

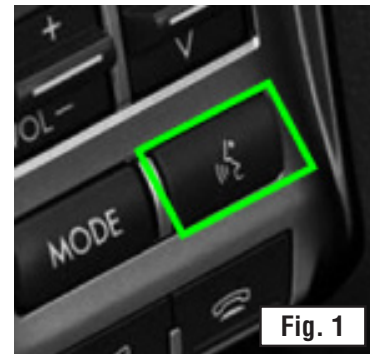
Fig. 1

CONDITION: Voice Recognition function does not recognize Navigation and/or Bluetooth hands-free commands.

For Navigation and Bluetooth hands-free voice commands, there is a hierarchy of commands which must be followed for proper operation.

1. First, press the “I Agree” button on the display screen or the voice recognition feature will not work properly
2. Press the Push to Talk button [Fig. 1](#)
3. After the Beep, say “Navigation”
4. A list of available navigation commands will appear on the screen. [Fig. 2](#)

1. Press the Push to Talk button [Fig. 1](#)
2. After the beep, say “Hands free”
3. A list of Bluetooth Handsfree commands will appear on screen [Fig. 3](#)

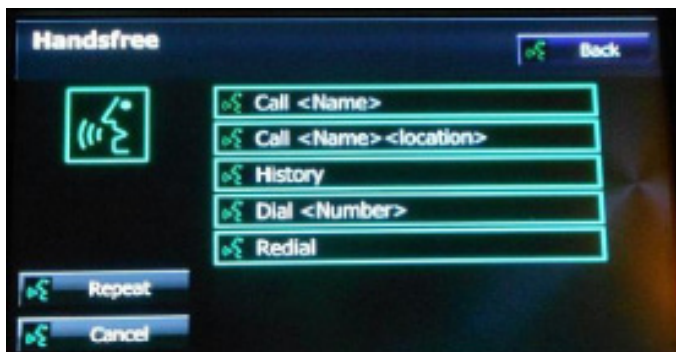
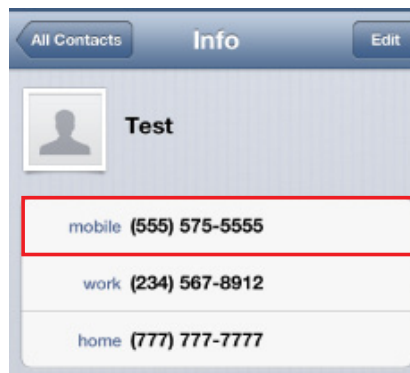
CONDITION: Voice Recognition function does not recognize “Call _____ cell phone”.
Name

The way the number is stored in the phone may not be listed as “cell phone”.

On the user’s cell phone, check to see how the person’s phone number is listed. If the number is listed as “mobile” you will need to use that term instead of the term “cell phone”.

Press the Push to Talk button. After the beep, say “Hands-free”. After the second beep, say “Call (Test) mobile”.
Name

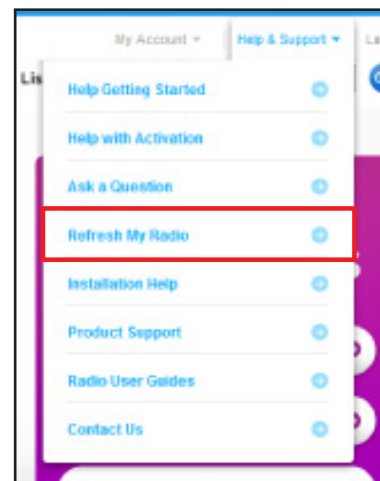
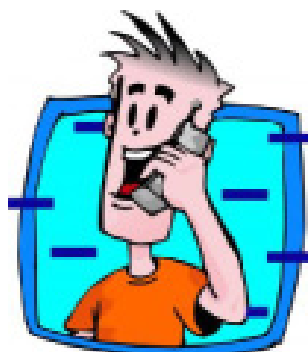
CONDITION: XM Traffic stopped working but XM Radio operates normally.

The user may have not paid for the Sirius XM traffic service after the Free Trial period expired.

1. Check with Sirius XM to verify the customer is subscribed to both Sirius XM Radio and Traffic.
2. After verifying an active subscription, with the vehicle outside, go to www.SiriusXm.com. Click on “Help and Support” then select “Refresh My Radio” to have another activation signal sent to the vehicle. Tune to channel 0 (zero) and the Radio ID number will display.
3. If the Traffic does not start working within about 15 minutes after sending the “Refresh” request, exchange the audio unit.

1. On www.Siriusxm.com, select “Help&Support”.
2. From the drop down menu, select “Refresh My Radio”
3. Input the “Radio ID #” then select “Send Activation Request”

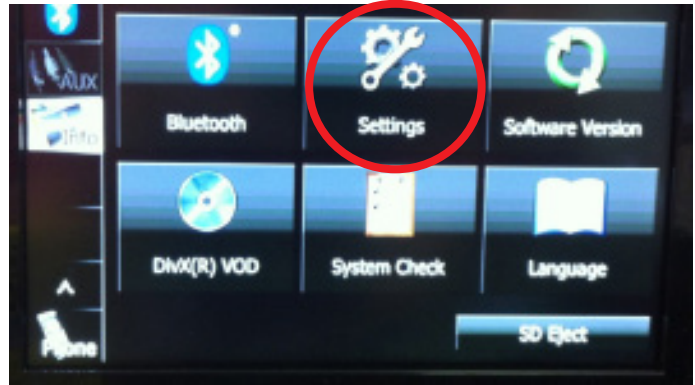
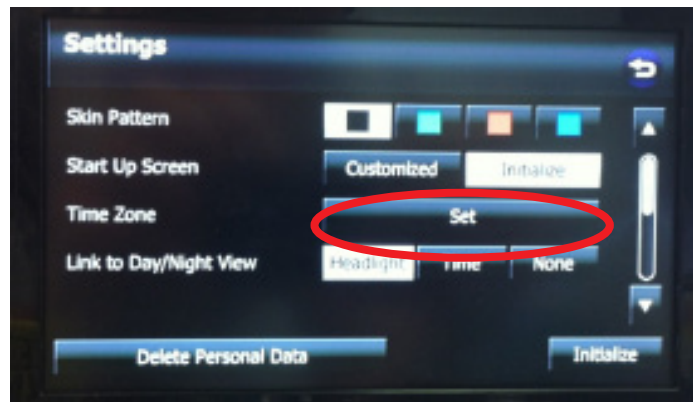
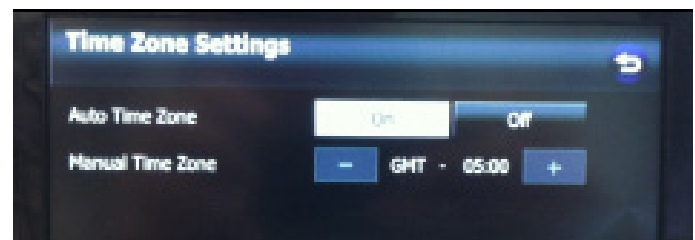
CONDITION: The clock shows the incorrect time.

The “Auto Time Zone” feature may be turned off.

If the clock’s time is incorrect, check the Time Zone setting and make sure “Auto Time Zone” feature is set to “On”.

1. Press the “Info” button
2. Press the “Settings” button
3. Press Time Zone “Set” button
4. Select Auto Time Zone “On”

If “Auto Time Zone” is turned off, the clock will need to be adjusted manually for different time zones.

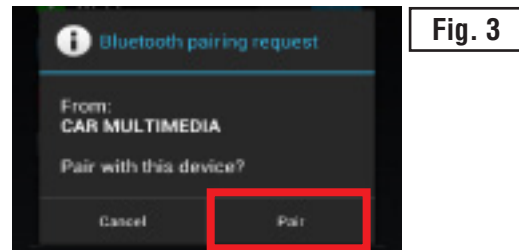
Fig. 3

CONDITION: 1. Bluetooth will not auto connect to specific phone models.

2. Bluetooth Handsfree and Bluetooth Audio do not operate after connecting to the system.

Bluetooth connection between the navigation unit and the phone will not connect without accepting the pairing request on the phone or in the phone's notification area.

1. Check the notification area on the phone for a pairing request (Figs 1 & 2).
2. Check the authentication screen for a pairing request, then select "Pair" (Figs. 3 & 4).
3. If the option for "Don't ask again" is available, make sure this box is checked. (Fig. 5)
4. After this process, the Bluetooth will connect. The user may need to perform this process again for future connections.

Select "Pair" or "Accept" when authentication screen pops up.
