Applies To: **2009–12 MDX – ALL**
2013 MDX – From VIN 2HNYD2..1DH500001 thru 2HNYD2..1DH505915

September 14, 2013

Rattle From Headliner

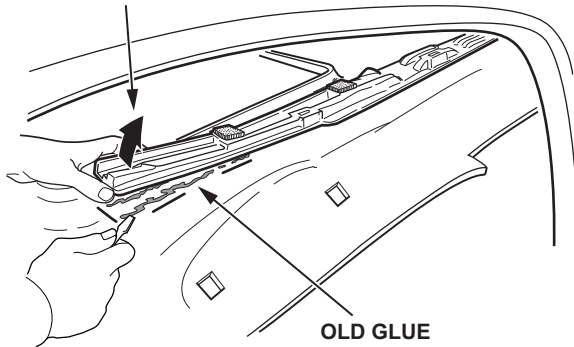
Lift detached end of stiffener.

8. Remove the old epoxy from the detached portion of the stiffener and the headliner. If the stiffener is still partially attached, do not remove it from the headliner.
