GROUP Chassis	MODEL 2011-2013MY Sorento (XM)
	NUMBER PS269	DATE April 2013

SUBJECT: GRINDING OR CREAKING NOISE WHEN TURNING

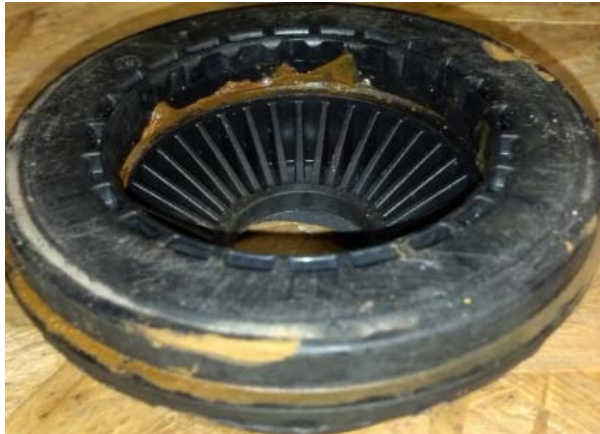
This article provides information regarding a potential grinding or creaking noise heard from the front of the vehicle when turning the wheel quickly at slow speeds, on some 2011 - 2013MY Sorento (XMa), produced prior to August 28, 2012. This concern may be caused by corrosion of the Front Strut Bearing due to water or debris entry and is more commonly found in regions with higher snowfall and road salt usage.

Verify the customer complaint of a grinding or creaking noise during turning and remove the front strut bearings for inspection. If there is a rough feeling when turning the bearing by hand, replace it with a new part and recheck to verify that the noise is no longer heard.
