MODEL  
2011-12MY  
Sorento (XM)

NUMBER  
051 [Rev 1, 5-3-2013]

## TECHNICAL SERVICE BULLETIN

SUBJECT: SERVICE ACTION: DRIVER'S SIDE POWER WINDOW  
MOTOR REFLASH PROCEDURE (SA 143A)

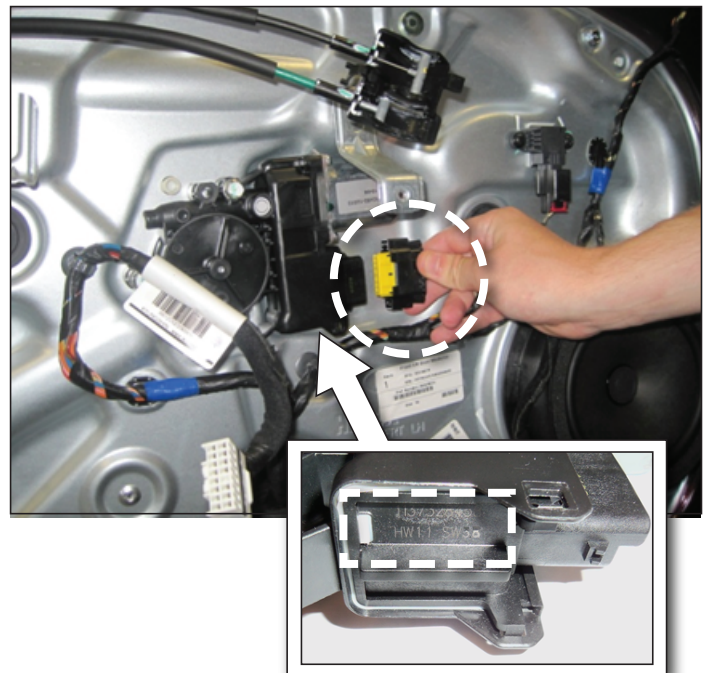
16. Confirm the software revision level by examining the area directly below the connector on the window motor. The embossed revision level should be 3.8 or 3.9. Window motors with a revision number of 3.10 (or higher) require no further action; proceed to Step 25.

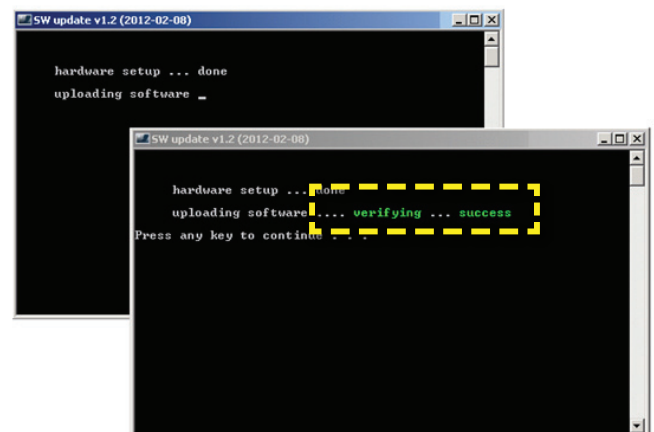
22. If the reflash procedure was successful, the screen will display the "success" message. Proceed to Step 24.

This reflash completes within a few seconds, then "success" will display in the window.

**DO NOT** attempt the reflash a second time, as doing so will result in a "communication error" message.

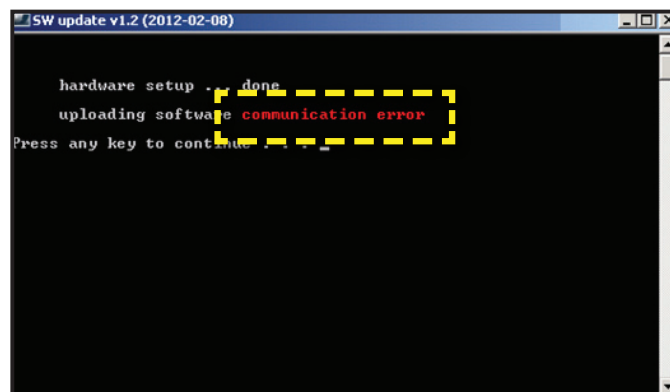
23. If the reflash procedure displays the message "communication error", check the following:

- Reflash tool power supply is properly connected.
- RS-232 cable connector is properly connected.
- Window motor cable connector is properly connected.

After all checks are complete, perform the reflash procedure a second time. If the communication error occurs again on the second attempt, this indicates the software is already up to date.
