MODEL
Rio (UB)
2012-2013MY

NUMBER
020

TECHNICAL SERVICE BULLETIN

PASSENGER FLOOR WET DURING A/C OPERATION.

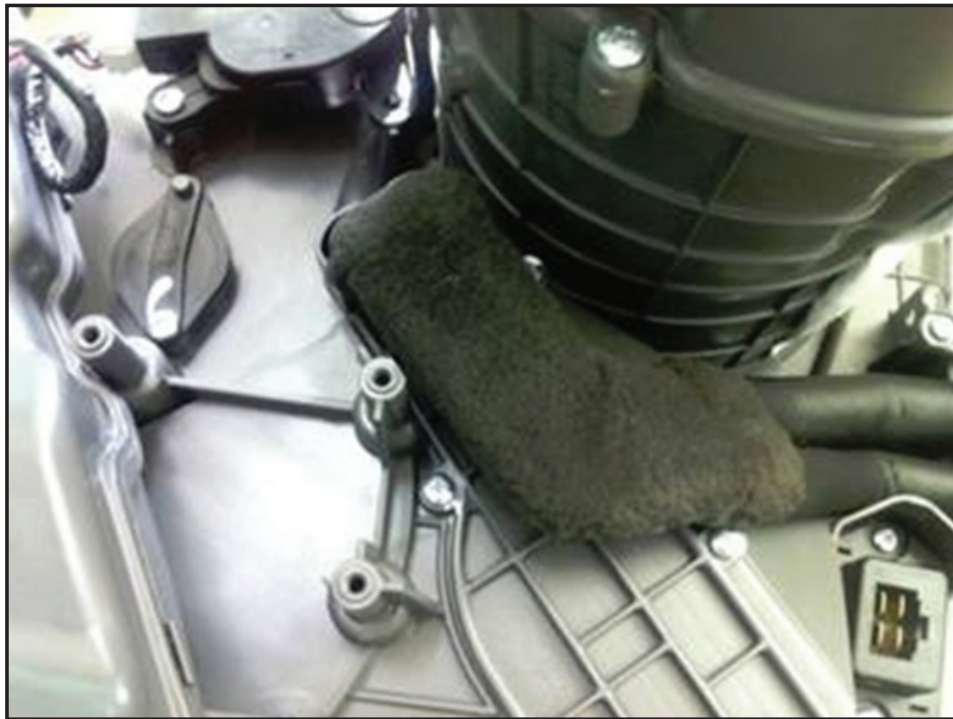
Evaporator Core Lines

This bulletin provides information relating to the possible presence of moisture on the passenger side floor during A/C operation on some Rio vehicles produced from October 15th, 2011 to September 20th, 2012 (for 4DR models) and July 11th, 2011 to September 20th, 2012 (for 5DR models). This condition may be due to insufficiently insulated evaporator lines allowing condensation to form on the lines which then drips onto the passenger floor. To correct this condition, install additional insulating material over the evaporator lines as outlined in this bulletin, making sure to completely wrap the lines from the evaporator core to the expansion valve, in order to prevent condensation from recurring.
