GROUP	MODEL
Body	2013MY Optima (QF)
NUMBER	DATE
098	June 2013

TECHNICAL SERVICE BULLETIN

SUBJECT: OPTIMA RIGHT HAND FENDER SPLIT REPAIR PROCEDURE

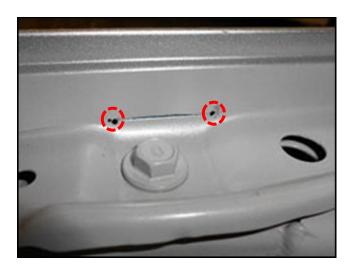
This bulletin provides information related to some 2013MY Optima (QF) vehicles, produced from May 17, 2013 to May 18, 2013, which may exhibit a split in the metal on the inner portion of the right hand side fender. This condition is only present on the right side fender. Follow the procedure outlined in this bulletin to repair the concern, without replacing the fender.

Use a 2mm bit to drill a hole at each end of the affected area.

Using a sanding pad and water, remove the paint from the affected area. Sanding should continue until the bare metal is visible.
