MODEL  
**2011-2012MY  
Sorento (XMa)**

NUMBER  
**099**

## TECHNICAL SERVICE BULLETIN

**SUBJECT:** COMBINED TSB/SERVICE ACTION: SORENTO FUEL FILLER DOOR  
OPERATION UPGRADE (SA146)

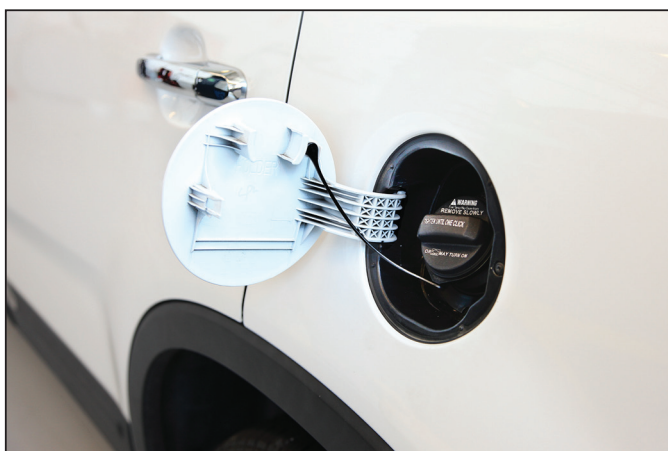
*Fuel Filler Door*

This bulletin provides information related to some Sorento (XMa) vehicles, produced from October 15, 2009 to September 29, 2011, which may exhibit a hard to open fuel filler door. Follow the procedure outlined in this bulletin to upgrade the operation of the fuel filler door.
