MODEL  
2012MY Sportage (SL)  
Turbo

NUMBER  
130

## TECHNICAL SERVICE BULLETIN

**SUBJECT:** SERVICE ACTION: ECM UPGRADE - REFLASH AND  
EWGA ADJUSTMENT PROCEDURE (SA 149)

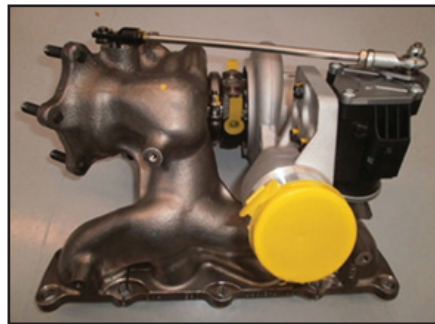
On some 2012 Sportage (SL) vehicles with 2.0 T-GDI engine produced from May 20, 2011 to January 17, 2012 the MIL may illuminate with DTC P2562 and/or P2565. To prevent and/or correct this condition, follow the procedures outlined in this bulletin to a) reflash the affected vehicle's control unit, and b) to check and if necessary adjust the Electronic Waste Gate Actuator (EWGA) rod length.

*Turbo and Boost Pressure  
Actuator Assembly*

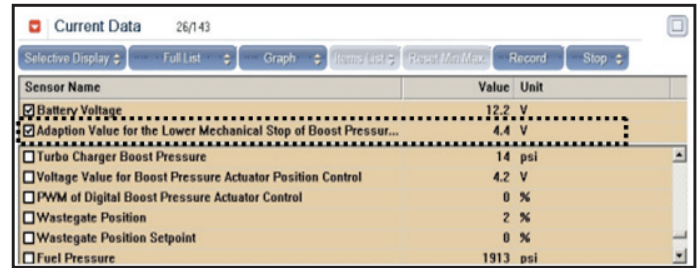
3. Under **Current Data**, select “**Adaptation Value for the lower mechanical Stop of Boost Pressure**”.

4. If the voltage is less than or equal to **4.2V**, no adjustment will be needed.  
If the voltage is greater than or equal to 4.3V; then adjust the EWGA rod length following the **EWGA ADJUSTMENT PROCEDURE** below.
