SERVICE BULLETIN

APPLICABILITY: 2012MY and Later Impreza Models with FB Engine **NUMBER:** 02-141-13R
 2011MY and Later Forester, N/A and Turbo Models **DATE:** 05/28/13
SUBJECT: Design Change to Rubber Sealing Cap for Oil **REVISED:** 08/07/13
 Pressure Switch

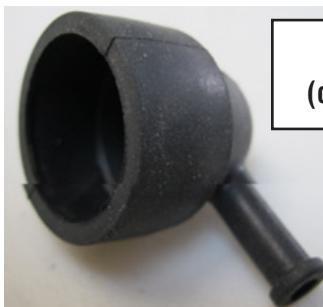
**Original
(old style) cap**

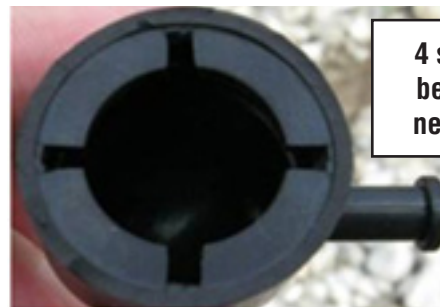
**4 seal breaks have
been added on the
new cap as shown.**

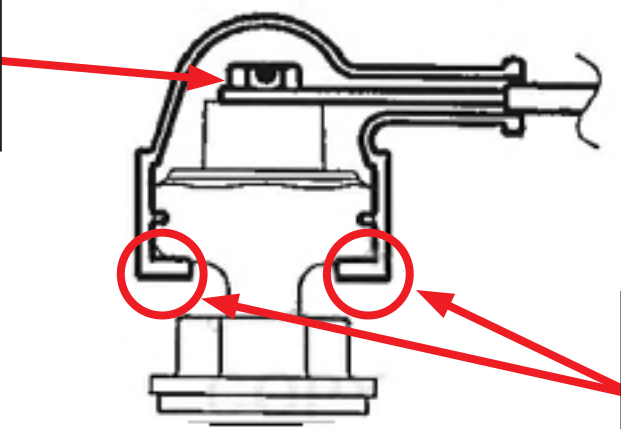
Be sure to follow the applicable procedure for tightening this electrical connection terminal as it varies by model.

The seal must be installed as shown with no roll-up of any of the edges.

Follow the procedure in the applicable Service Manual if replacing the oil pressure switch. Be sure to follow the proper torque procedure for both the switch **and** the electrical connection where applicable as it varies by model. The rubber material used to make the cap is soft and pliable enough so the wire and terminal eyelet can be pushed through the “tube” portion easily. Use a little bit of dielectric grease on the terminal eyelet as a lubricant if necessary. Confirm the new rubber cap is installed as shown in the illustration above with no roll-up of the bottom sealing edges.
