## SERVICE BULLETIN

**APPLICABILITY:** 2013MY BRZ

**NUMBER:** 12-140-12R

**SUBJECT:** “Clack” or “Popping” Sound from Trunk and /or Rear Shelf Area

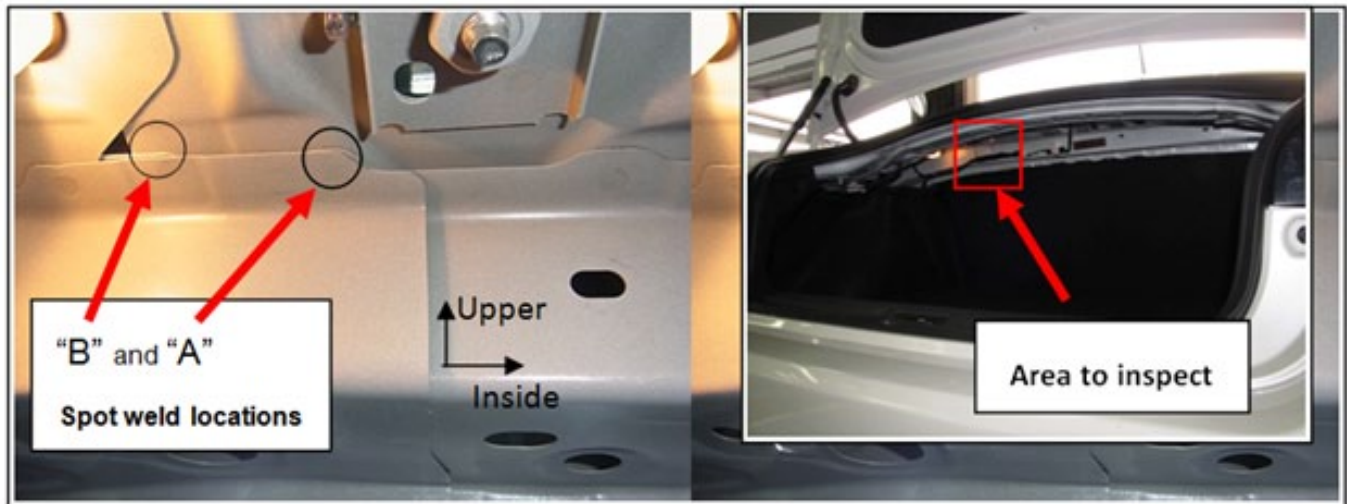
The photo below shows the location of the area of the spot weld to inspect on the Driver's (left) side.
