Subject: MIL ON WITH DTC P2610	Bulletin No: 01-001/13
	Last Issued: 01/16/2013

2014 Mazda6

2013-2014 CX-5

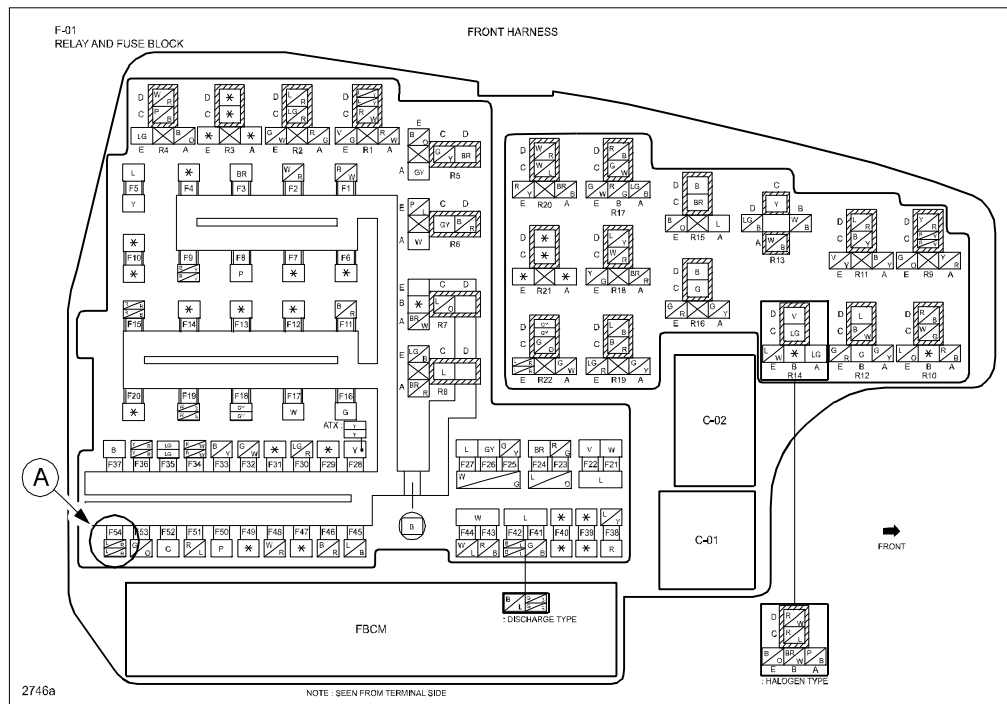
Some vehicles may experience MIL illumination with DTC P2610 (Instrument cluster internal engine off timer performance problem) stored in memory after engine start and room fuse 15A (A) removed.

1. Verify DTC P2610 is stored in PCM memory.
2. With the ignition off, install ROOM fuse 15A.
3. Clear DTC P2610 from PCM memory using IDS.
4. Verify no other DTCs are stored in memory. If so, troubleshoot them according to the MS3 online instructions or Workshop Manual.

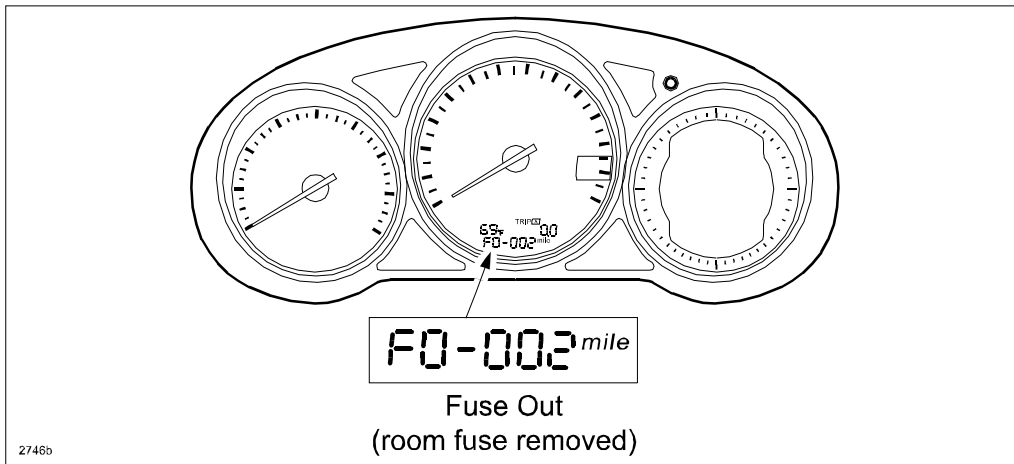
NOTE: The odometer will display "F0-002" during transport mode (room fuse 15A removed). Transport mode is canceled when room fuse 15A is installed or the vehicle odometer is more than 12.4mi (20km).
