Service Bulletin

Subject: SHOCK ABSORBER REPLACEMENT GUIDELINES	Bulletin No:	02-001/13
SHOCK ADSORDER REPEACEMENT GOIDELINES	Last Issued:	01/14/2013

APPLICABLE MODEL(S)/VINS

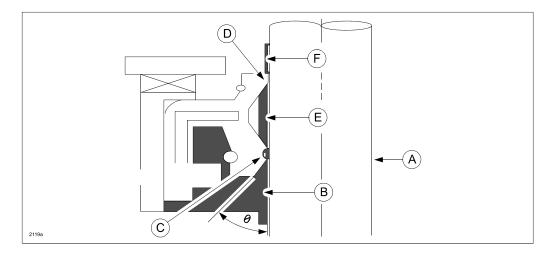
Oil seepage is caused by the following factors and is not a problem:

- A small amount of oil seeps outside through the dust lip during normal operation.
- The oil film thickness is uneven due to production variation of rod and seal.

When the rod (A) receives input from the road and extends upward, most of the oil (B) on the rod is scraped off by the main lip (C) and some remains inside the dust lip (D). When the rod extends further, then most of the remaining oil (E) on the rod is scraped off by the dust lip, and a small amount of oil seeps out (F).

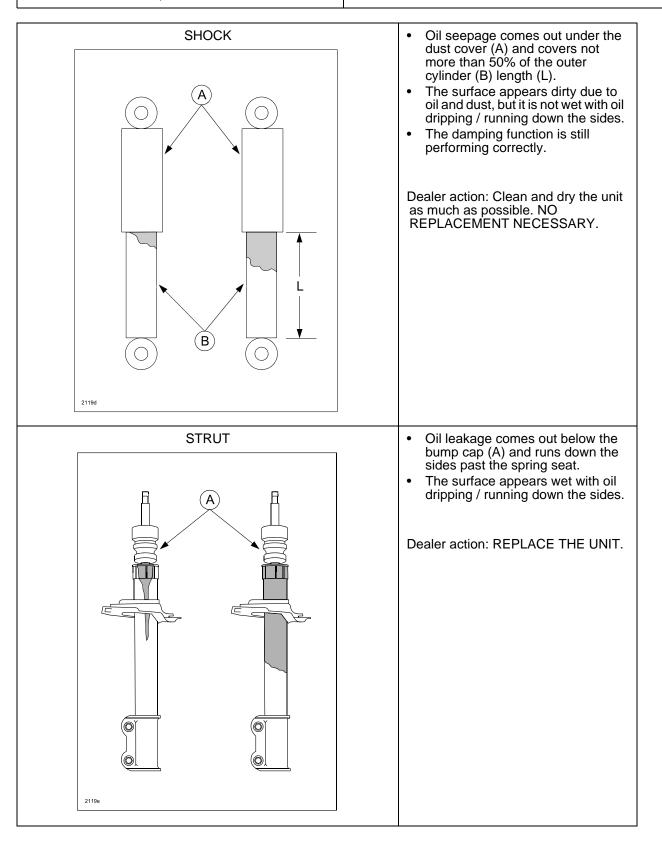
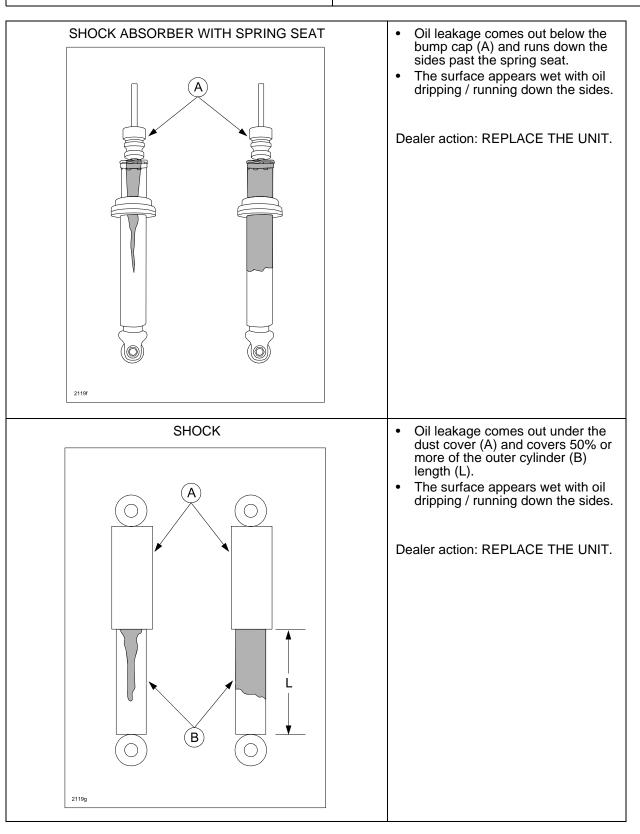
SYMPTOM	DESCRIPTION / REPLACEMENT CRITERIA
STRUT	 Oil seepage comes out below the bump cap (A) and may run down the sides, but does not run past the spring seat. The surface appears dirty due to oil and dust, but it is not wet with oil dripping / running down the sides. The damping function is still performing correctly. Dealer action: Clean and dry the unit as much as possible. NO REPLACEMENT NECESSARY.
SHOCK ABSORBER WITH SPRING SEAT	 Oil seepage comes out below the bump cap (A) and may run down the sides, but does not run past the spring seat. The surface appears dirty due to oil and dust, but it is not wet with oil dripping / running down the sides. The damping function is still performing correctly. Dealer action: Clean and dry the unit as much as possible. NO REPLACEMENT NECESSARY.
