Service Bulletin

Subject:
 Bulletin No:
 01-001/13

MIL ON WITH DTC P2610
 Last Issued:
 01/07/2013

2014 Mazda6 2013-2014 CX-5

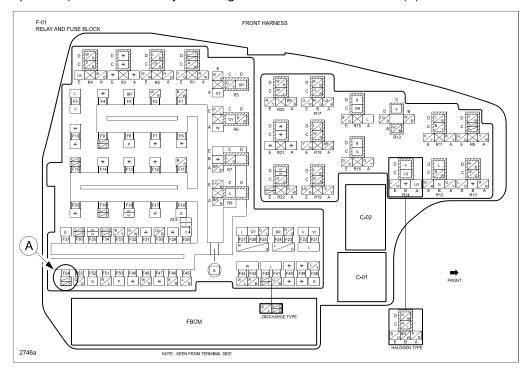
Some vehicles may experience MIL illumination with DTC P2610 (Instrument cluster internal engine off timer performance problem) stored in memory after engine start and room fuse 15A (A) removed.

- 1. Verify DTC P2610 is stored in PCM memory.
- 2. With the ignition off, install ROOM fuse 15A.
- 3. Clear DTC P2610 from PCM memory using IDS.
- 4. Verify no other DTCs are stored in memory. If so, troubleshoot them according to the MS3 online instructions or Workshop Manual.
