Subject: LACK OF POWER WITH MIL ON - DTCs - P2187 / P2177	Bulletin No: 01-009/13
	Last Issued: 02/26/2013

2007-2009 CX-7 2.3L turbo

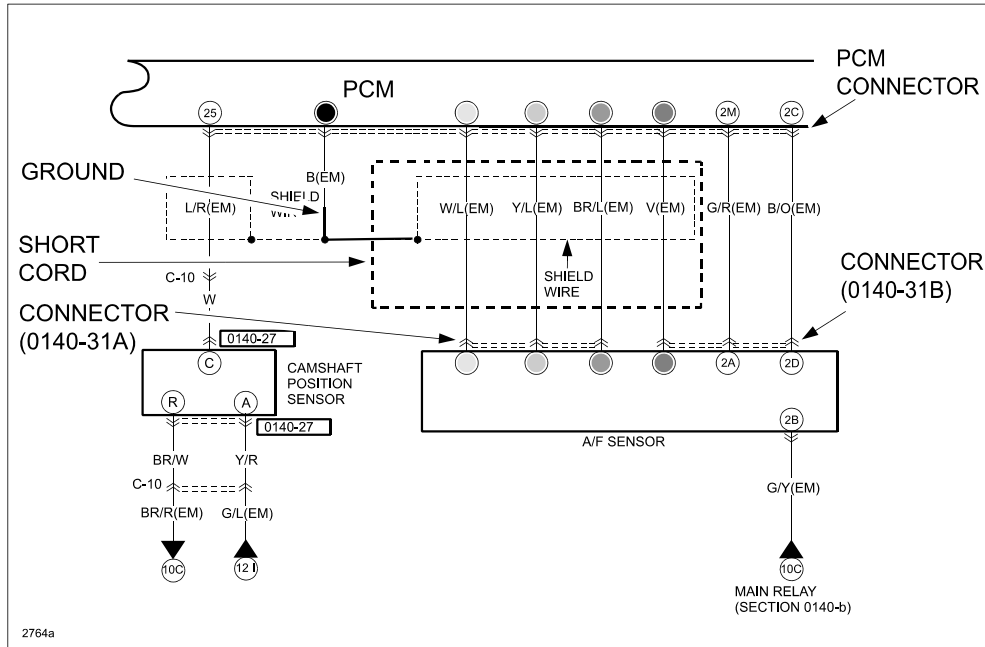
1. Verify the customer's concern; MIL is illuminated and DTCs P2187 / P2177 are stored in memory.
2. Verify if an A/F wire was shorted to the shield wire according to the "Inspection" steps below.
