© 2013 Mazda Motor of America, Inc.

Subject: 2013 CX-5 - CHIRP NOISE FROM RIGHT REAR AT 60 MPH OR MORE	Bulletin No: 09-001/13
	Last Issued: 02/15/2013

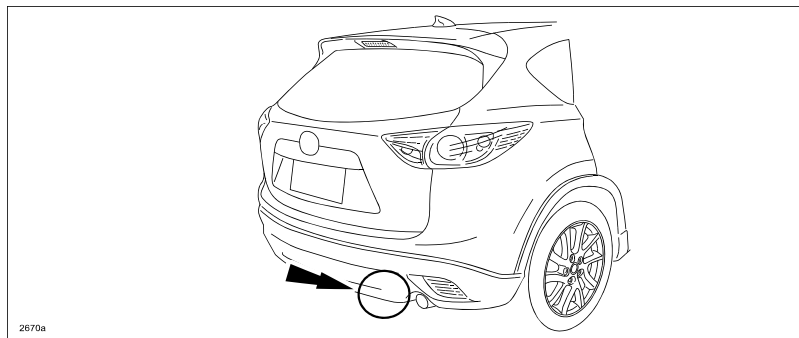
While driving at approx. 60 mph or more, some vehicles may exhibit a chirp noise from rear right end of the vehicle.

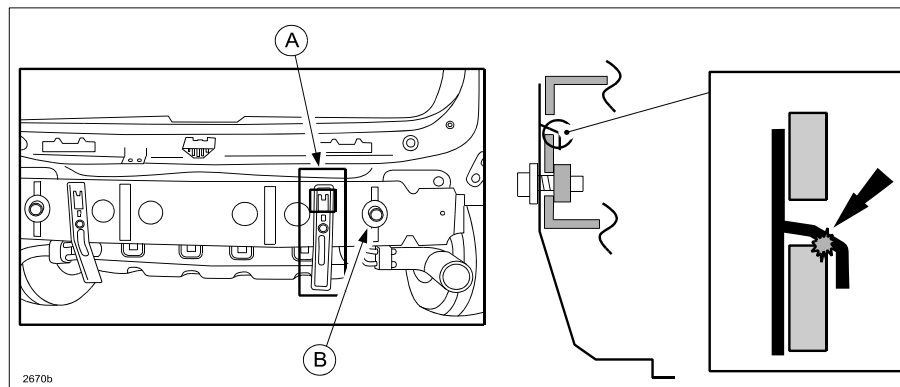
The chirp noise may be caused by the right side rear bumper stay hook (A) contacting the bumper reinforcement (B) at high speed. The shape of the reinforcement hole has been changed on both sides to eliminate the noise.

Customers having this concern should have their vehicle repaired using the following repair procedure.

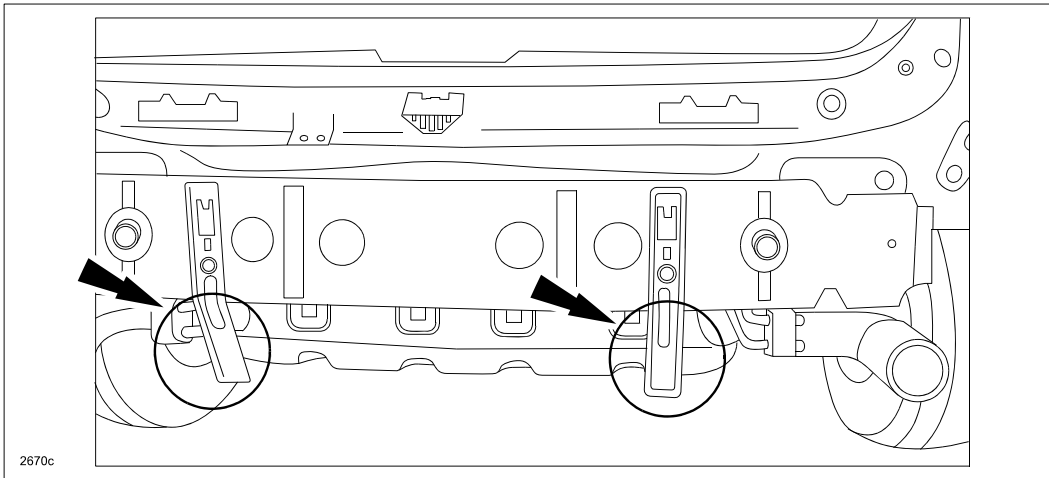
1. Verify the customer concern by lightly tapping the left and right sides of the rear bumper by hand.
 - If the noise is heard on either side, follow the repair procedure below to eliminate the concern.
 - If the noise is not heard on either side, this service bulletin is not applicable.
2. Remove the rear bumper from the vehicle according to the instructions on MS3 online or the Workshop Manual (section 09-10 REAR BUMPER REMOVAL/INSTALLATION).
3. Confirm the chirp noise again by hitting the lower side of left and right bumper stays by hand.

NOTE: Even if there is no chirp noise on the left side, perform the repair on both sides.
