<b>Subject:</b>  <b>UNUSUAL ENGINE NOISE AFTER A COLD ENGINE START</b>	<b>Bulletin No:</b> 01-006/13
	<b>Last Issued:</b> 02/13/2013

2013-2014 CX-5

2014 Mazda6

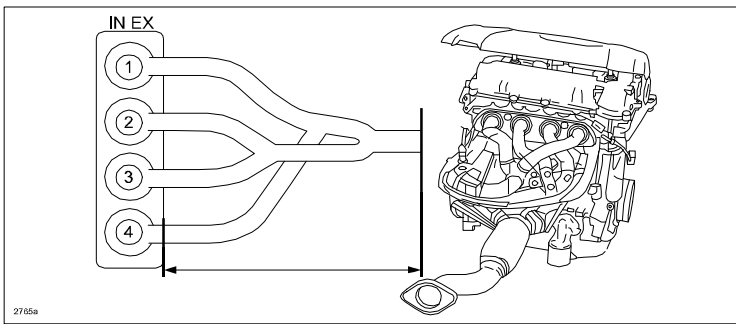
<p>SKYACTIV-G</p>	<p style="text-align: center;"><b>Long Exhaust Pipes (4-2-1 Type)</b></p>

The SKYACTIV-G engine is equipped with 4-2-1 exhaust manifold to improve the fuel economy and engine power. The distance from the engine to the catalytic converter is longer than previous engines such as the LF engine. This longer distance does not allow the catalytic converter to warm up quickly. To off-set this condition, AWS has been developed by burning fuel inside the exhaust manifold for 20 seconds to quickly warm up the catalytic converter. The customer may identify the burning sound as an unusual noise.

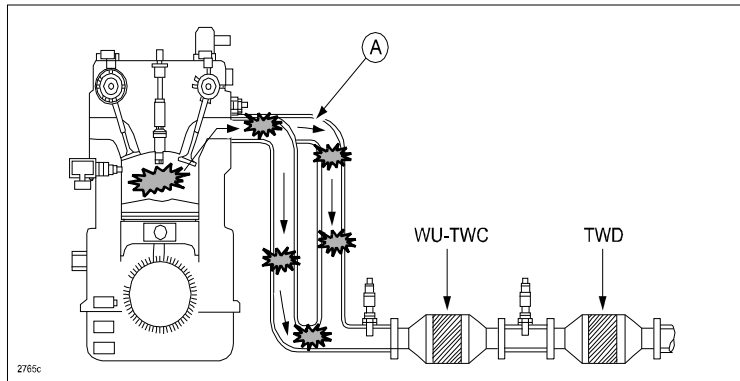
AWS burns fuel inside the exhaust manifold (A) to quickly warm up the catalytic converter. The customer may identify the burning sound as an unusual noise.
