Subject: REPLACEMENT PROCEDURES FOR THE TRANSFER OIL SEALS (RIGHT SIDE)	Bulletin No: 03-002/13
	Last Issued: 03/28/2013

2010-2013 CX-9 equipped with AWD

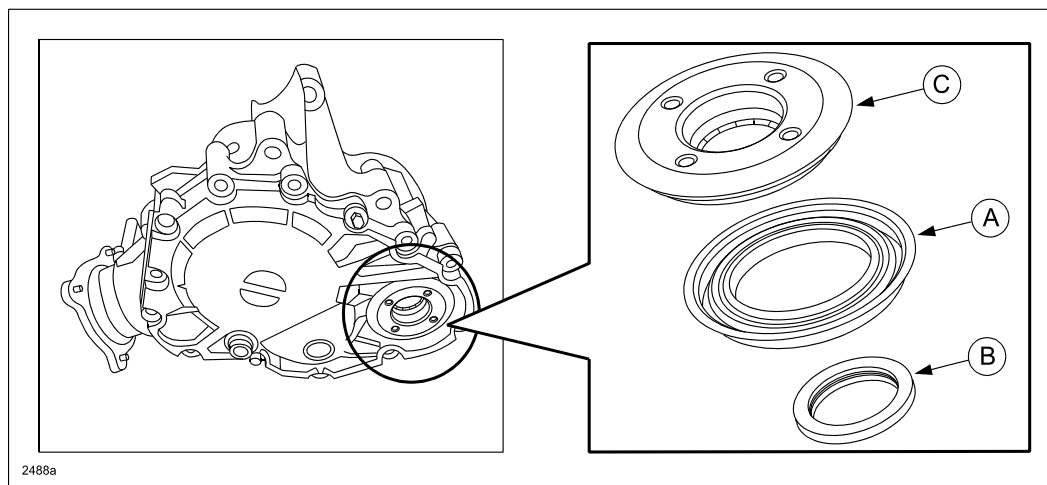
If replacement of the right side (RH) transfer oil seal (A), and transfer dust seal (B) are necessary, use the following REPAIR PROCEDURE to install the new oil seals.

NOTE: Deflector (C) may not be reused.

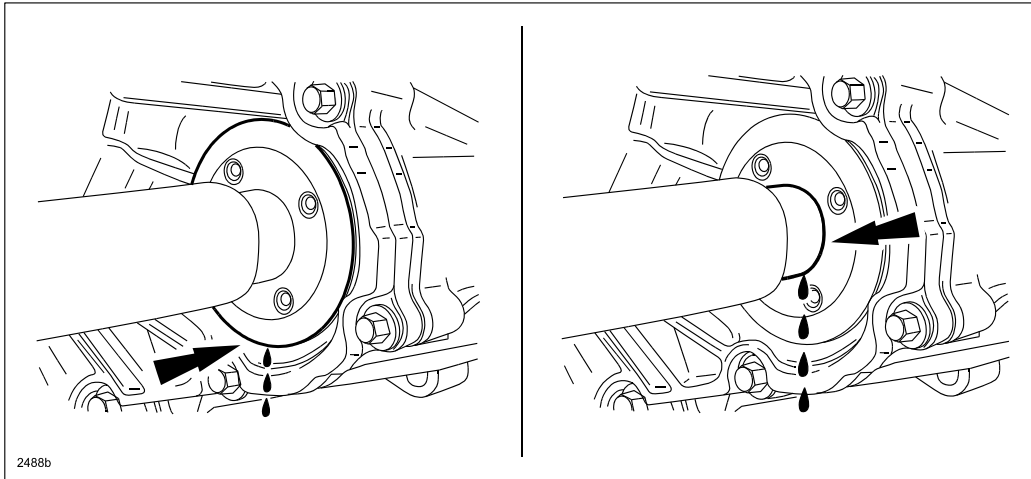
The transfer may leak different color fluids, red automatic transmission fluid (ATF) and tan/brown/black transfer gear oil. The transfer oil seal (A) prevents transfer gear oil leakage. It is important to note which color fluid is leaking to determine the most appropriate service.

1. Lift the vehicle. For additional information, refer to MS3 online or Workshop Manual (section 00-00 JACKING POSITIONS, VEHICLE LIFT (2 SUPPORTS) AND SAFETY STAND (RIGID RACK) POSITIONS).
2. Is there a fluid leak from the RH side of the transfer?

- Yes - Proceed to Step 3.
 - No - This bulletin does not apply. Refer to normal Workshop Manual diagnosis.
3. Inspect the transfer vent located on top of the transfer. Is the transfer vent restricted (mud/debris)?
 - Yes - Clear external restrictions from the transfer vent and proceed to step 25.
 - No - Proceed to step 4.
 4. What is the color of the fluid leak?
 - Tan/brown/black (transfer gear oil leak) - Proceed to Step 5.
 - Red ATF leak - This bulletin does not apply. Red ATF leak indicates the transaxle seal is leaking and needs to be replaced. Refer to MS3 online or Workshop Manual (section 05-17 OIL SEAL (DIFFERENTIAL) REPLACEMENT [AY6A-EL, AY6AX-EL]).
 5. Remove the RH wheel.
 6. Remove the RH side cover.

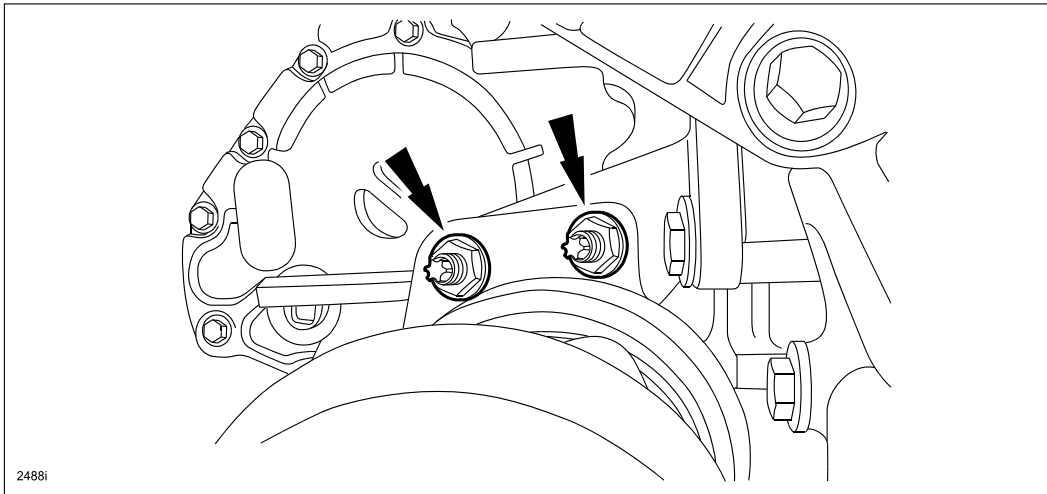
CAUTION: The sharp edges of the drive shaft can slice or puncture the oil seals. Be careful when removing the drive shaft from the transaxle.

15. Remove the 2 RH drive shaft bolts and the drive shaft assembly.
