Subject: RATTLE NOISE FROM PASSENGER SIDE DASHBOARD	Bulletin No: 09-008/13
	Last Issued: 03/21/2013

2014 Mazda6 vehicles with VINs lower than JM1 GJ ***** 109218 (produced before February 4, 2013)

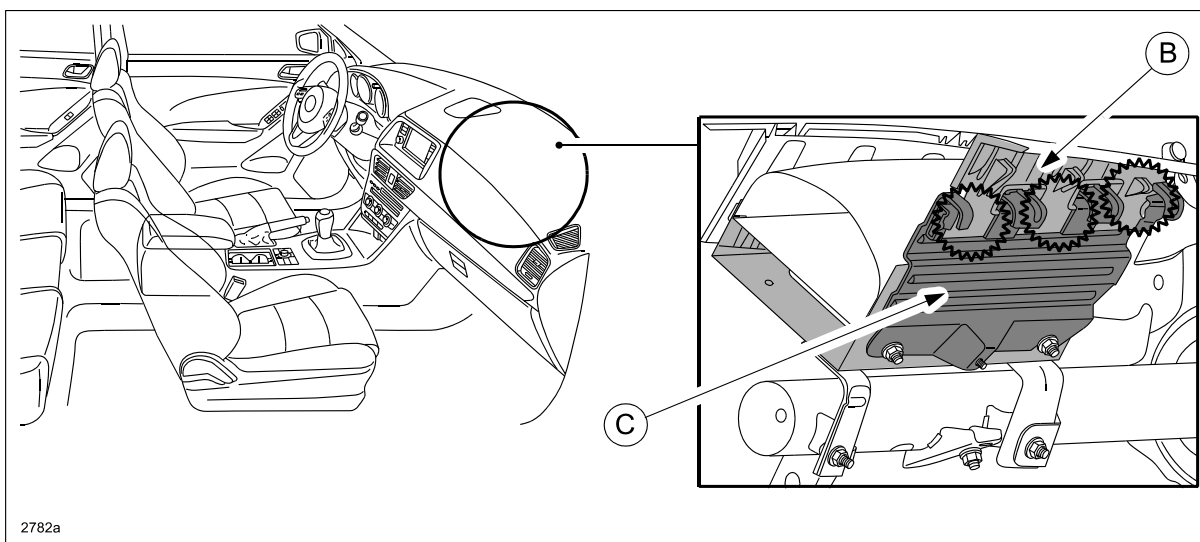
Some vehicles may exhibit a rattle type noise from the passenger side dashboard when driving on a rough road.

This noise may be caused by the passenger-side air bag module bracket (C) contacting the bracket holder (B) when driving on a rough road.

Add non-woven fabric between the passenger-side air bag module bracket and the bracket holder.
