© 2013 Mazda Motor of America, Inc.

Subject: UNUSUAL NOISE FROM EXHAUST PIPE SEAL RING	Bulletin No: 01-012/13
	Last Issued: 03/18/2013

2011-2013 Mazda2

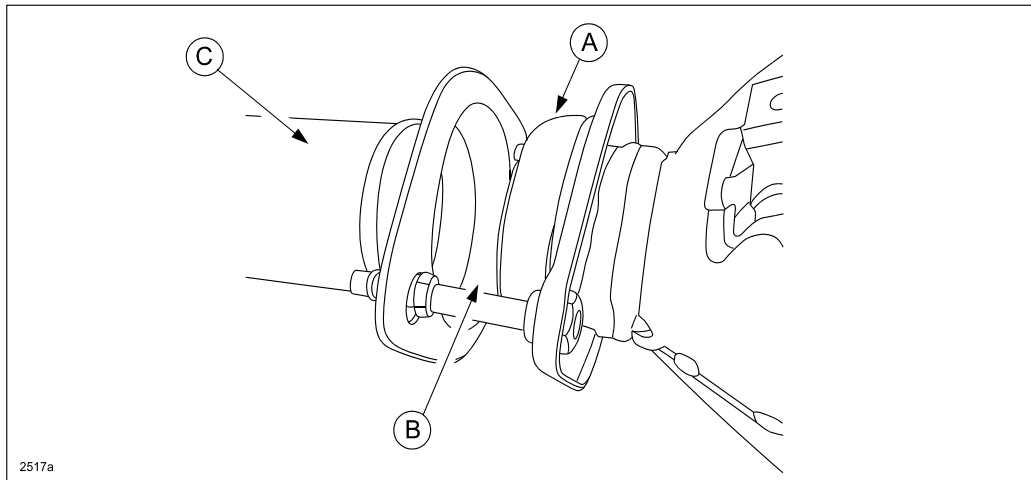
Due to engine vibration and a lack of seal ring lubrication, the mesh in the seal ring (A) rides in the flared portion (B) of the catalytic converter (C) resulting in a slight noise from the exhaust system while the engine is running.

The friction between the exhaust system parts and the resulting slight noise are normal. This friction does not cause breakage, gas leakage, or other functional problems with the vehicle's exhaust system.

During normal vehicle aging, the noise level may change as the surface of the metal flange deteriorates. Usually this noise cannot be heard when the engine is running, however the noise may be heard in a quiet environment when the customer is outside the vehicle or when a door or window is open.

Customers having this concern should have their vehicle repaired using the following repair procedure.

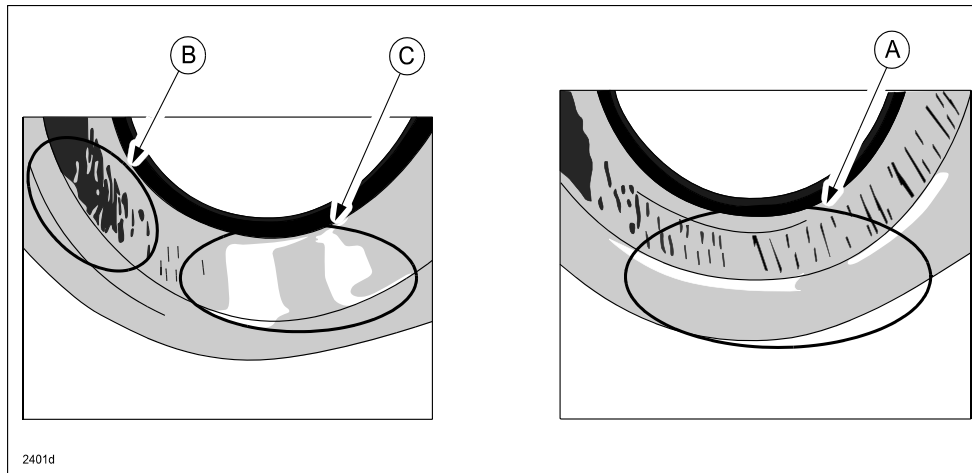
10. If severe damage appears on round surface of catalytic converter-side flared flange (A), replace catalytic converter.

NOTE: If the catalytic converter is replaced and a black coating (B) remains on the round surface of the flared flange, the white coating of the seal ring will stick to the black coating, which may cause noise. Be sure to sufficiently polish the flange (C).

9. Run your finger over seal ring installed location (flange) of exhaust manifold. If surface feels rough, use #80 sandpaper until rough surface is gone, then use fine sandpaper until bare metal is exposed.
