Subject: CLICKING NOISE WHEN OPENING TRUNK LID	Bulletin No: 09-006/13
	Last Issued: 03/28/2013

2014 Mazda6 vehicles with VINs lower than JM1 GJ ***** 109003 (produced before February 01, 2013)

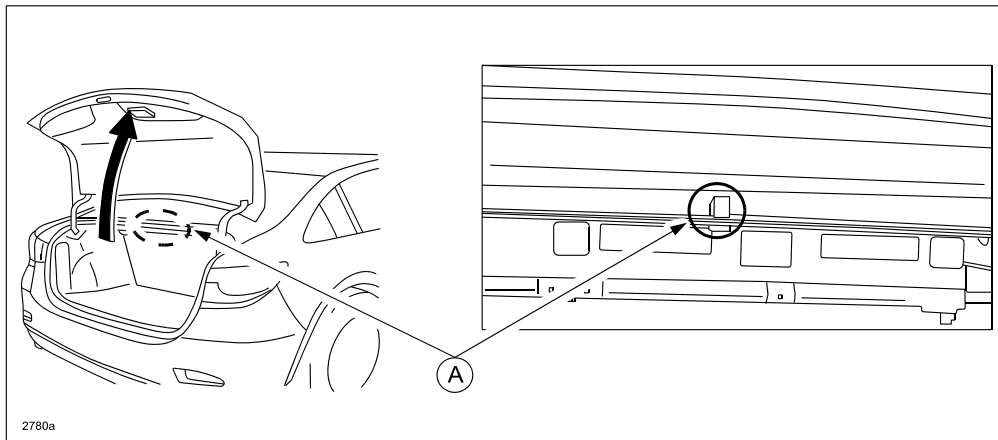
Some vehicles may exhibit a clicking type noise when the trunk lid is fully opened or just before the fully open position. The twisting motion of the trunk lid balance springs (A) may cause the clip fixing the balance springs to move and scrape against the rear package tray panel.

Customers having this concern should have their vehicle repaired using the following repair procedure.
