Subject: WIND NOISE FROM REAR DOOR AREA	Bulletin No: 09-007/13
	Last Issued: 03/13/2013

2013 CX-5 vehicles with VINs lower than JM3KE*****140662 (produced July 30, 2012)

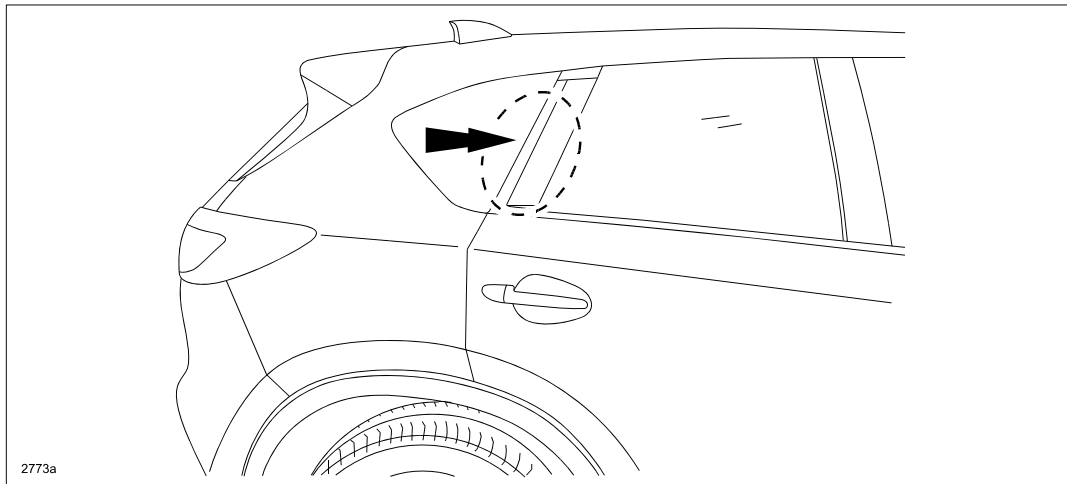
Some vehicles may exhibit wind noise that occurs from the rear door quarter glass while driving at approx. 25 mph (40Km/h). The noise may be caused by a gap between the rear door quarter glass and the rear door garnish. A soft pad has been attached to the rear door quarter glass guide to eliminate the noise.
