Subject: EXCESSIVE CONDENSATION OR WATER WITHIN THE HEADLAMP ASSEMBLY - CAUTION	Bulletin No: 09-003/13
	Last Issued: 03/04/2013

APPLICABLE MODEL(S)/VINS

2011-2013 Mazda2	2007-2014 Mazda6	2007-2012 CX-7	2006-2013 MX-5
2007-2013 Mazda3	2008-2011 Tribute	2007-2013 CX-9	
2006-2013 Mazda5	2013-2014 CX-5	2007-2011 RX-8

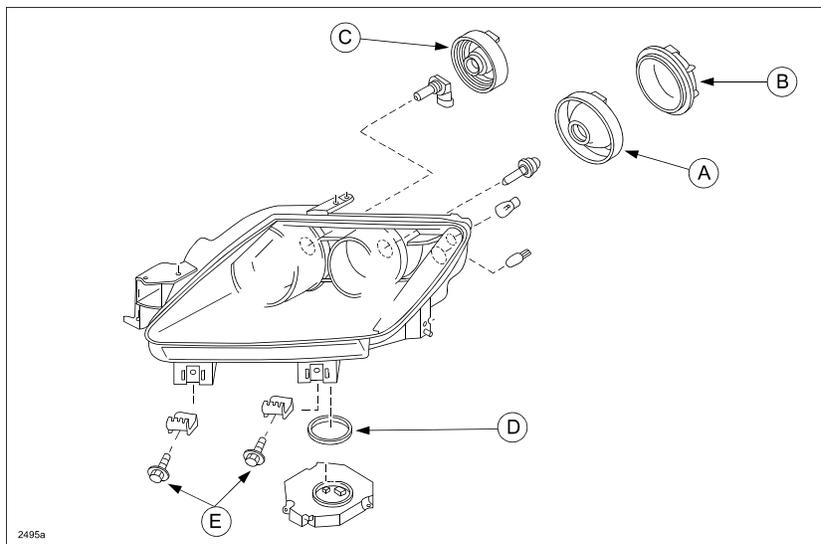
When dealing with customer complaints of excessive condensation and/or water within the headlamp unit, first determine if all the bulb sockets are present and correctly installed. In most cases you will find that the Bulb Seal No. 1 (A) or HID Bulb Seal No. 1 (B) and Bulb Seal No. 2 (C) socket covers have not been correctly installed or are missing due to improper prior repairs (i.e., customer replacing the headlamp bulbs or body shop not transferring them when replacing the headlamp unit(s) due to a collision). Any damage caused by missing socket covers, HID module seal (D), or missing bumper brackets (E) is not covered by warranty policy.
