Subject: UNABLE TO LOWER REAR SEATBACK WITH REMOTE HANDLE / SEATS HARD TO LOCK	Bulletin No: 09-013/13
	Last Issued: 04/29/2013

2013-2014 CX-5 vehicles equipped with a 4:2:4 split type rear seat with VINs lower than JM3KE*****318331 (produced before Feb. 1, 2013)

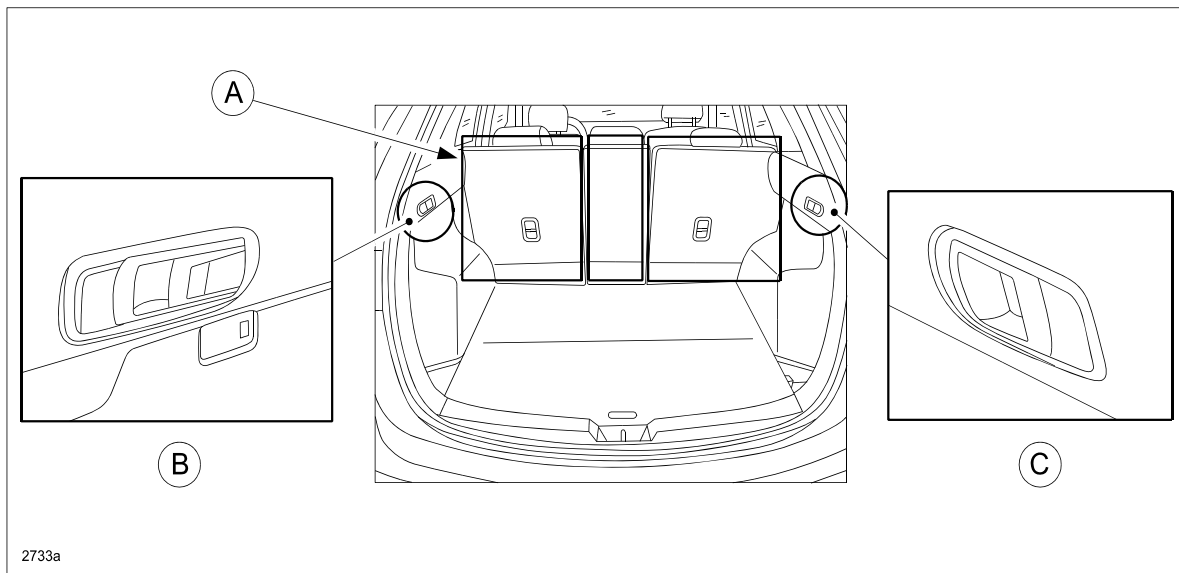
Some vehicles equipped with a 4:2:4 split type rear seat may be unable to lower the rear seatback (A) when pulling the left (B) and/or right (C) remote handles. Also, the seatbacks may not fully latch (lock) when placed in the upright position.

This concern may be caused by an incorrect seatback remote cable adjustment position. The current adjustment position may not provide enough tension for the cable to unlock the seatback latches.

The position of the seatback remote cable adjustment has been changed to the center position at mass-production.

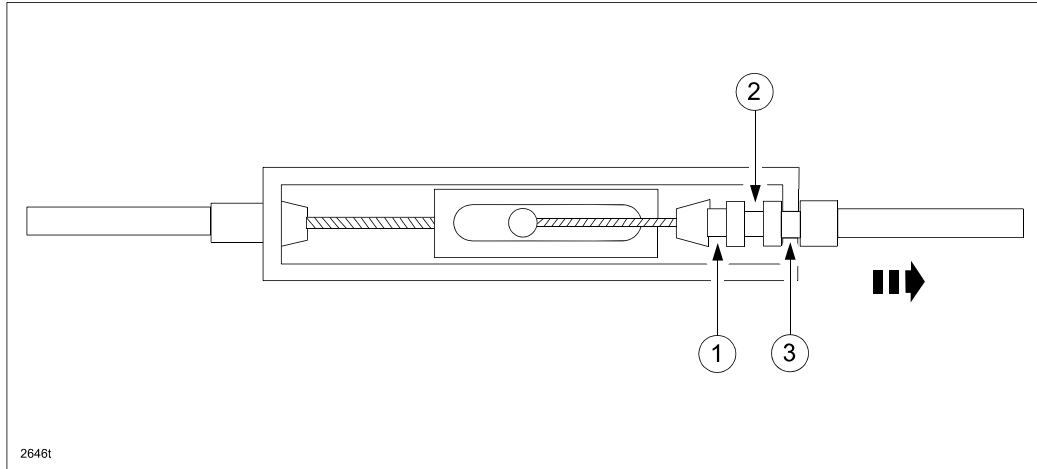
- Using a small flathead screwdriver, pop open the affected remote cable adjuster housing and check the current cable adjustment setting position (1, 2 or 3) as shown below.

NOTE: Cable adjustment setting position "3" is the factory setting for vehicle produced before **Feb. 1, 2013**.

- Pull the cable out of the housing and change the setting to position "2", then snap the remote cable adjuster housing closed.
- Using the appropriate remote handle lever, check the seat back for proper releasing and locking operation.
