Subject: NOISE FROM FRONT DOOR CHECKER AREA	Bulletin No: 09-012/13
	Last Issued: 04/29/2013

2013-2014 CX-5

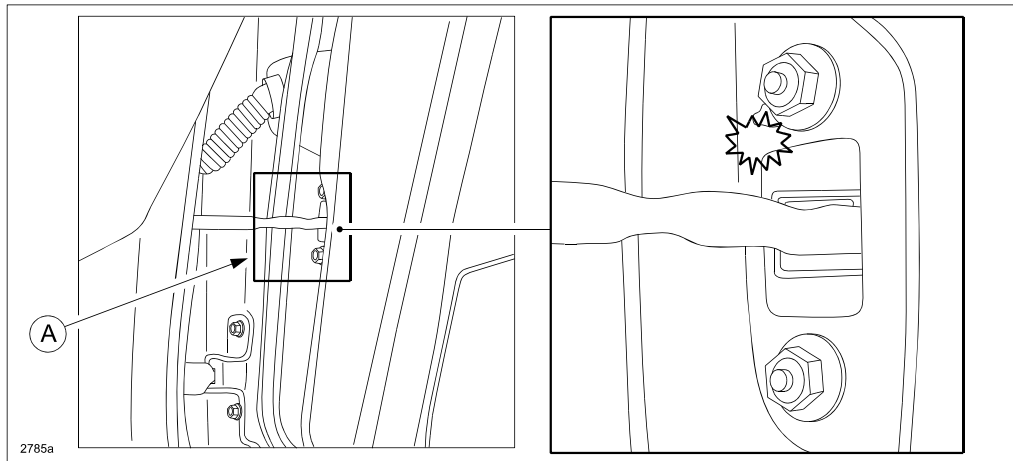
Some vehicles may experience noise from the front door checker installation location (A) whenever the door is opened. When the door is fully opened, the door checker may become over-stroked and cause a crack at the spot welding area around the door checker.

Customers having this concern should have their vehicle repaired using the following repair procedure.
