Subject: RATTLE NOISE FROM FRONT DOOR GLASS	Bulletin No: 09-011/13
	Last Issued: 04/17/2013

2013-2014 CX-5 vehicles with VINs lower than JM3KE*****300112 (produced before November 28, 2012)

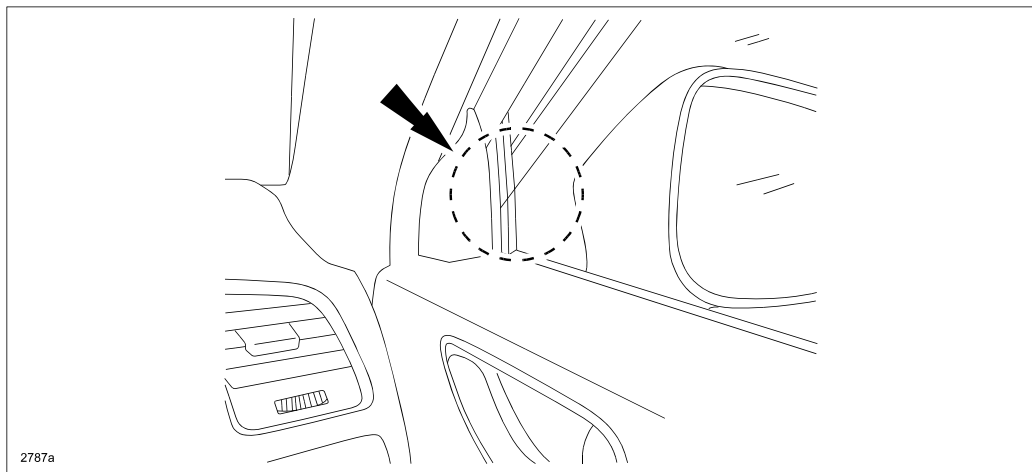
Some vehicles may experience a rattle noise from the front door glass when driving with the window open approx. 1/2 to 4 inches (1 - 10cm).

The rattle noise may be caused by insufficient glass run channel holding force. To eliminate this concern, the shape of glass run channel has been changed in order to increase the holding force.
