Subject: DOOR MIRROR BASE COVER DISCOLORATION	Bulletin No: 09-009/13
	Last Issued: 04/04/2013

2013 CX-5 vehicles with VINs lower than JM3KE*****138997 (produced July 24, 2012)

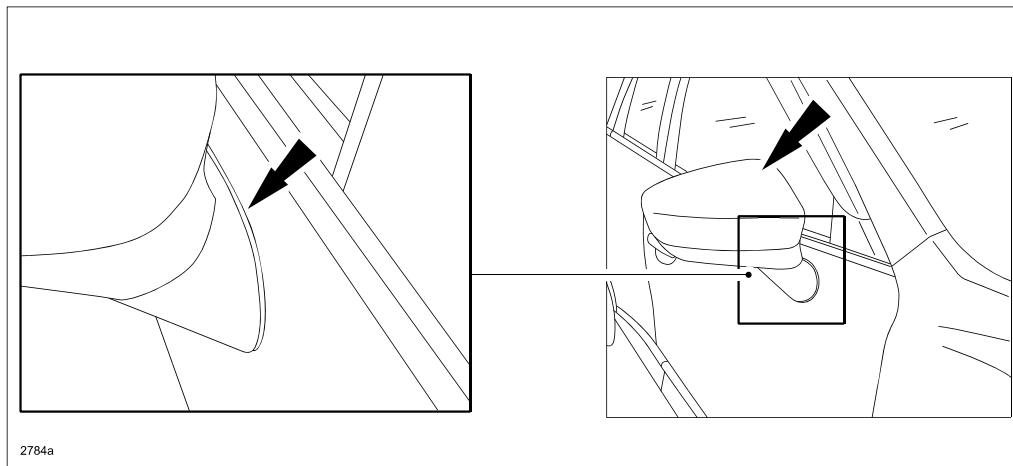
Some vehicles may experience a discoloration (from black to white) of the outer door mirror base cover. The material used for the mirror base cover has been changed to eliminate this concern.

Customers having this concern should have their vehicle repaired using the following repair procedure.
