Service Bulletin Mazda North American Operations

Bulletin No: 09-017/13 Subject:

POWER LIFTGATE CLOSES BUT DOES NOT LATCH COMPLETELY

Last Issued: 05/28/2013

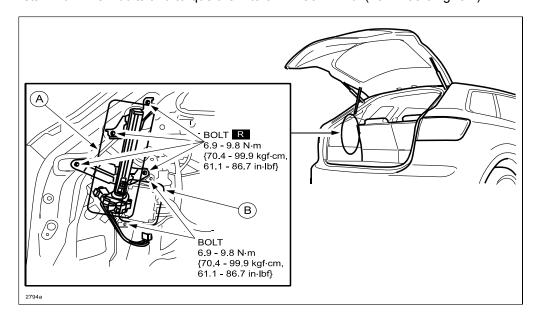
Some customers may experience a power liftgate (PLG) that closes but does not latch completely when the PLG button is pressed.

- 1. Verify customer concern.
- 2. Disconnect the negative battery cable.
- 3. Replace the PLG driver and PLG slider (A). Refer to MS3 online or Workshop Manual:
 - PLG driver section 09-11 POWER LIFTGATE (PLG) DRIVE UNIT REMOVAL/INSTALLATION
 - PLG slider section 09-11 POWER LIFTGATE (PLG) SLIDER REMOVAL/INSTALLATION

NOTE: Install with 4 new bolts and torque them to 61.1 - 86.7 in-lbf (70.4 - 99.9 kgf-cm).

4. Replace the PLG control module (B). Refer to MS3 online or Workshop Manual (section 09-11 POWER LIFTGATE (PLG) CONTROL MODULE REMOVAL/INSTALLATION).

NOTE: Install with 2 new bolts and torque them to 61.1 - 86.7 in-lbf (70.4 - 99.9 kgf-cm).
