Subject: SQUEAK NOISE FROM ENGINE COMPARTMENT	Bulletin No: 01-013/13
	Last Issued: 05/28/2013

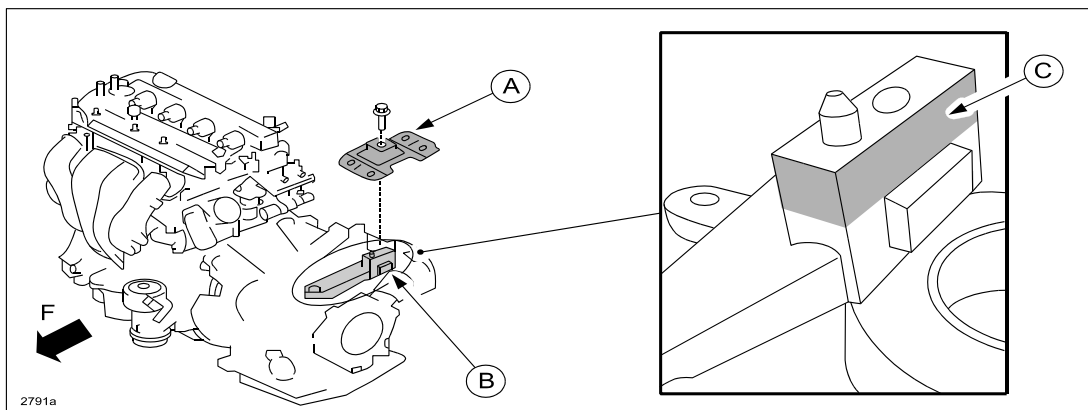
Some vehicles may exhibit a squeak noise from the engine compartment when the vehicle starts moving and/or at the time of transmission shifting. This is caused by stick-slip noise occurring at the contact surfaces between the No. 4 engine mount rubber and the No. 4 engine mount bracket when the engine shakes back and forth.

1. Verify customer concern.
2. Remove the No. 4 engine mount rubber (A) from the No. 4 engine mount bracket (B). Refer to MS3 online instructions or Workshop Manual:
 - Mazda3 SKYACTIV - (section 01-10 ENGINE REMOVAL/INSTALLATION [SKYACTIV-G 2.0]).
 - Mazda3 MZR 2.0, 2.5 - (section 01-10 ENGINE REMOVAL/INSTALLATION [MZR 2.0, MZR 2.5]).
 - Mazda5 - (section 01-10 ENGINE REMOVAL/INSTALLATION [MZR 2.5]).
3. Clean the surfaces of the No. 4 engine mount bracket (C) where it contacts the mount rubber.
