Subject: KNOCKING / SQUEAKING NOISE FROM FRONT STRUT BEARING	Bulletin No: 02-005/13
	Last Issued: 05/24/2013

2013-2014 CX-5 vehicles with VINs lower than JM3KE*****343674 (Produced before April 16, 2013)

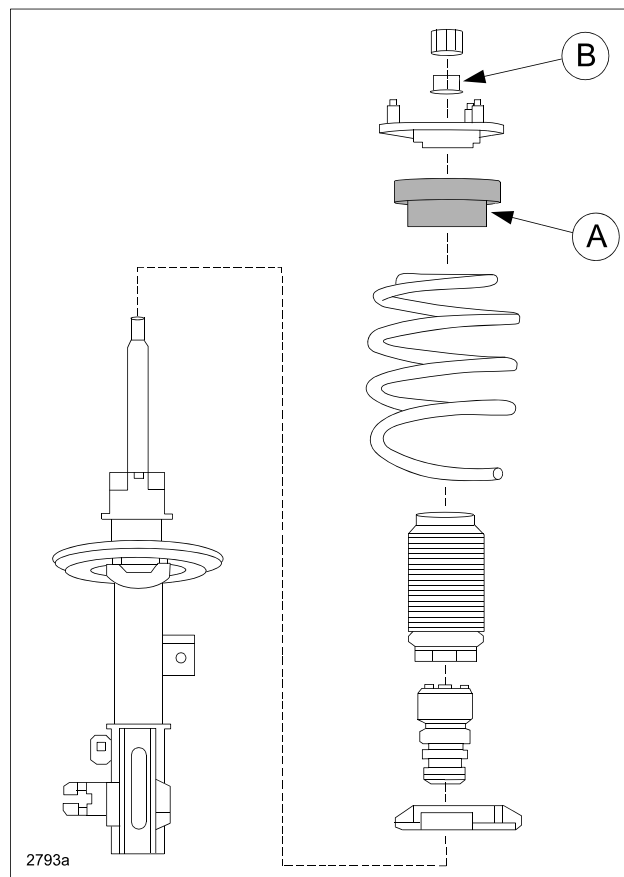
Some vehicles may exhibit a knocking / squeaking noise from the front strut bearing (A) due to front strut bearing damage when driving on rough roads and/or when turning the steering wheel while the vehicle is stopped.

The noise may be due to the upper housing of the front strut bearing being damaged when applying excessive force to the bearing during customer use. To eliminate the noise, the material and production method of the front strut bearing has been changed.

NOTE: The piston rod nut (B) requires replacement when the front strut bearing is replaced.

1. Verify the noise is coming from the upper part of front shock absorber when turning the steering wheel.
2. Replace the front strut bearing with a new one according to MS3 online instructions or the Workshop Manual (section 02-13 FRONT SHOCK ABSORBER AND COIL SPRING DISASSEMBLY/ASSEMBLY).
3. Verify repair.
