Subject: REAR MOUNT CAMERA DOES NOT OPERATE	Bulletin No: 09-016/13
	Last Issued: 05/07/2013

2013 CX-5 with VINs lower than JM3KE*****155008 (produced before October 7, 2012)

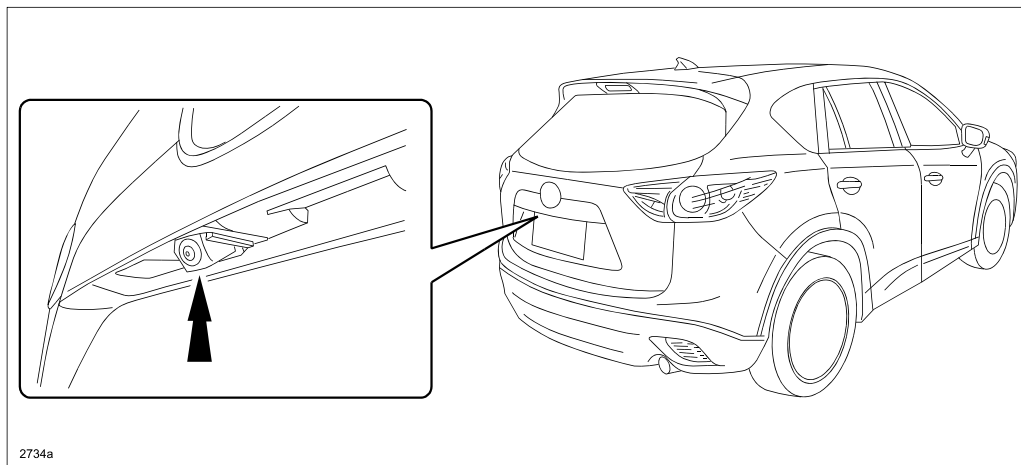
Some vehicles may exhibit an inoperative rear mount camera. This concern may be caused by water entering inside the camera during a high-pressure car wash.

The shape of the camera has been changed to eliminate this concern.
