Service Bulletin Mazda North American Operations

Subject: Bulletin No: 09-014/13

SUNROOF WATER LEAK AFTER HIGH PRESSURE CAR WASH

Last Issued: 05/03/2013

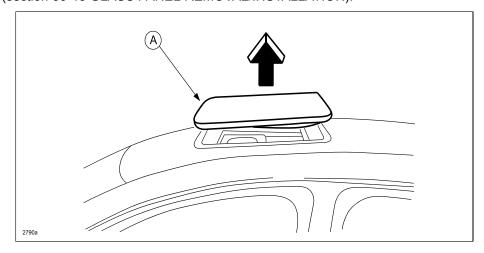
Some customers may experience a water leak from the sunroof after washing the vehicle with a high-pressure car wash system. High pressure water from the car wash may drip from the drip rail and leak into the cabin.

- 1. Verify customer concern.
- 2. Remove the sunroof glass panel (A). Refer to MS3 online or Workshop Manual:
 - Mazda6 (section 09-15 GLASS PANEL REMOVAL/INSTALLATION).
 - CX-5 (section 09-15 GLASS PANEL REMOVAL/INSTALLATION).
 - CX-9 (section 09-15 GLASS PANEL REMOVAL/INSTALLATION).
