<b>Subject:</b> <b>RATTLE / VIBRATION NOISE FROM RIGHT REAR OF VEHICLE</b>	<b>Bulletin No:</b> 09-022/13
	<b>Last Issued:</b> 07/31/2013

2013 CX-5 vehicles equipped with theft-deterrent with VINs lower than JM3 KE\*\*\*\*\* 169135 (produced November 19, 2012)

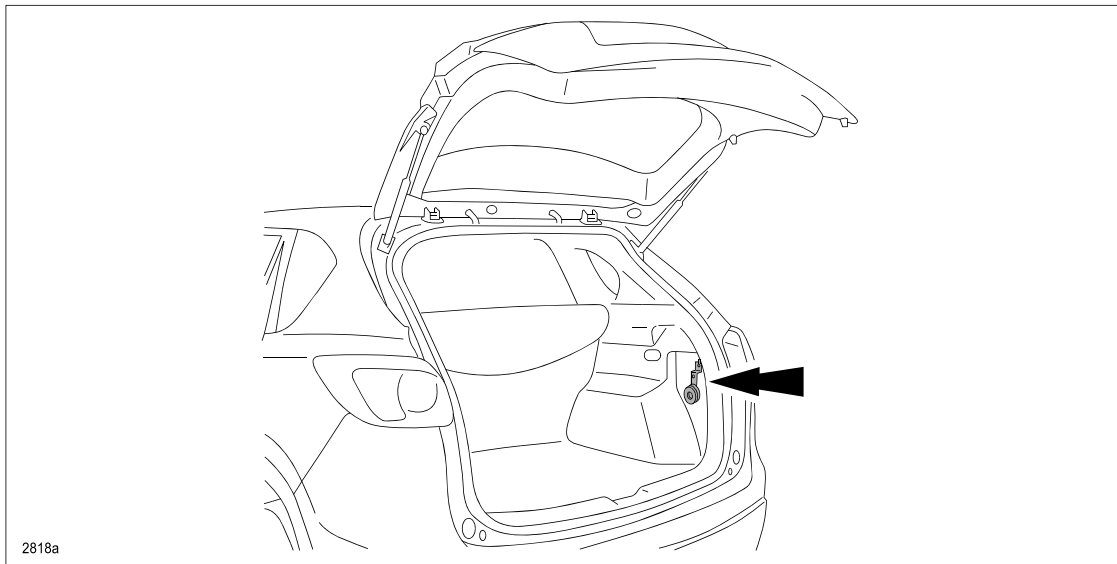
Some vehicles may exhibit a rattle/vibration noise coming from the right rear of the vehicle when closing the right rear door or trunk lid. The noise may also occur while driving on rough road surfaces.

The noise may be caused by vibration from the theft-deterrent horn bracket.

An EPT sealer has been attached to the theft deterrent horn during mass-production to eliminate the noise. Customers having this concern should have their vehicle repaired using the following repair procedure.
