Subject: EXCESSIVE OPERATING NOISE WHEN SLIDING POWER SEAT	Bulletin No: 09-021/13
	Last Issued: 07/19/2013

2014 Mazda6 equipped with power seats with VINs lower than JM1GJ*****125980 (produced June 1, 2013)

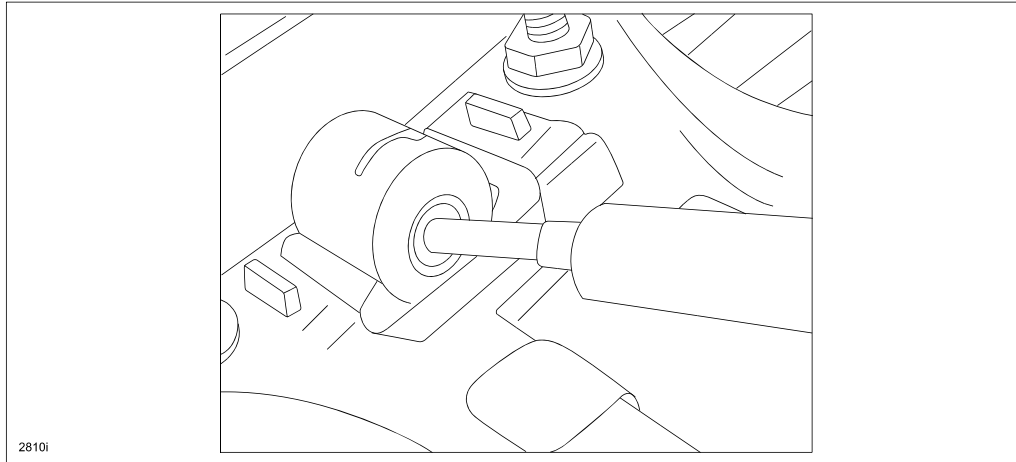
- If the cable is bent too much during installation, operation noise may occur. **DO NOT** hold the cable around the tip.

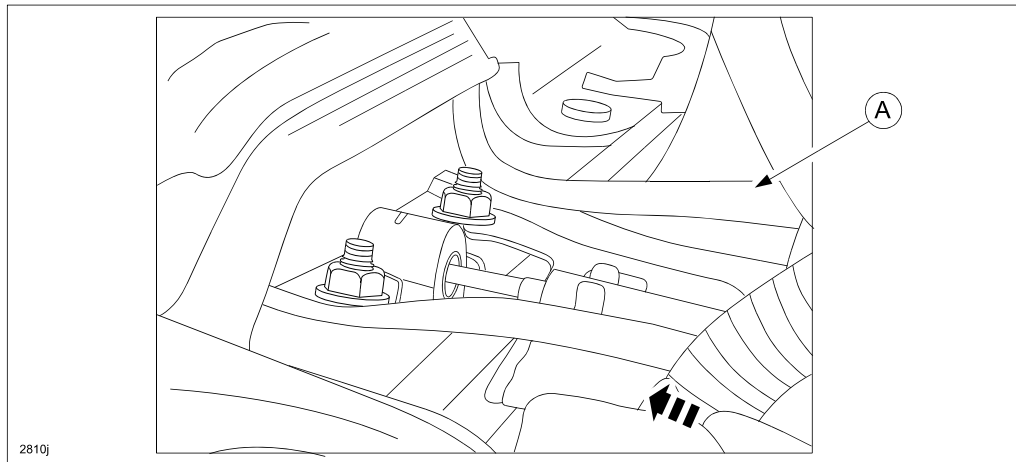
- If work space is too dark to see properly, use a light to illuminate the spot where the cable should be installed.
- Take caution not to pinch the seat belt buckle harness (A).
