© 2013 Mazda Motor of America, Inc.

Subject: LACK OF POWER / WRENCH LIGHT COMES ON WITH DTCs P0123 / P0222	Bulletin No: 01-017/13
	Last Issued: 07/02/2013

2011-2013 CX-9 with VINs lower than JM3TB*****419830 (produced May 1, 2013)

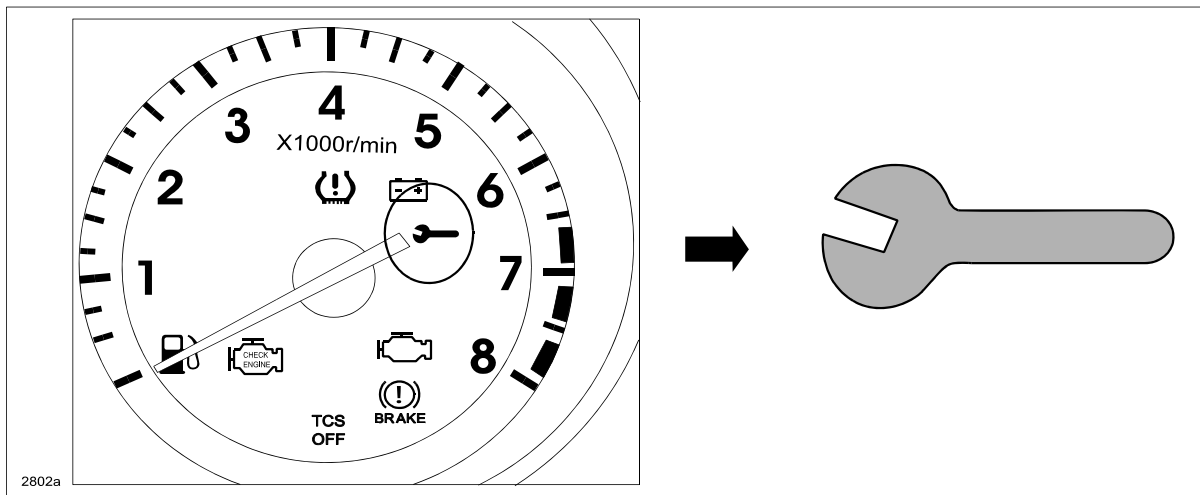
Some vehicles may experience a lack of power and the wrench light comes on with DTCs P0123 / P0222 stored in memory.

Wrench Light: Powertrain Malfunction / Reduced Power Warning Light
